Summary of Large-Scale C-shaped Reinforced Concrete Wall Tests

Anahid Behrouzi, Tufts University
Andrew Mock, SCA Consulting Engineers
Dr. Laura Lowes, University of Washington
Dr. Dawn Lehman, University of Washington
Dr. Daniel Kuchma, Tufts University

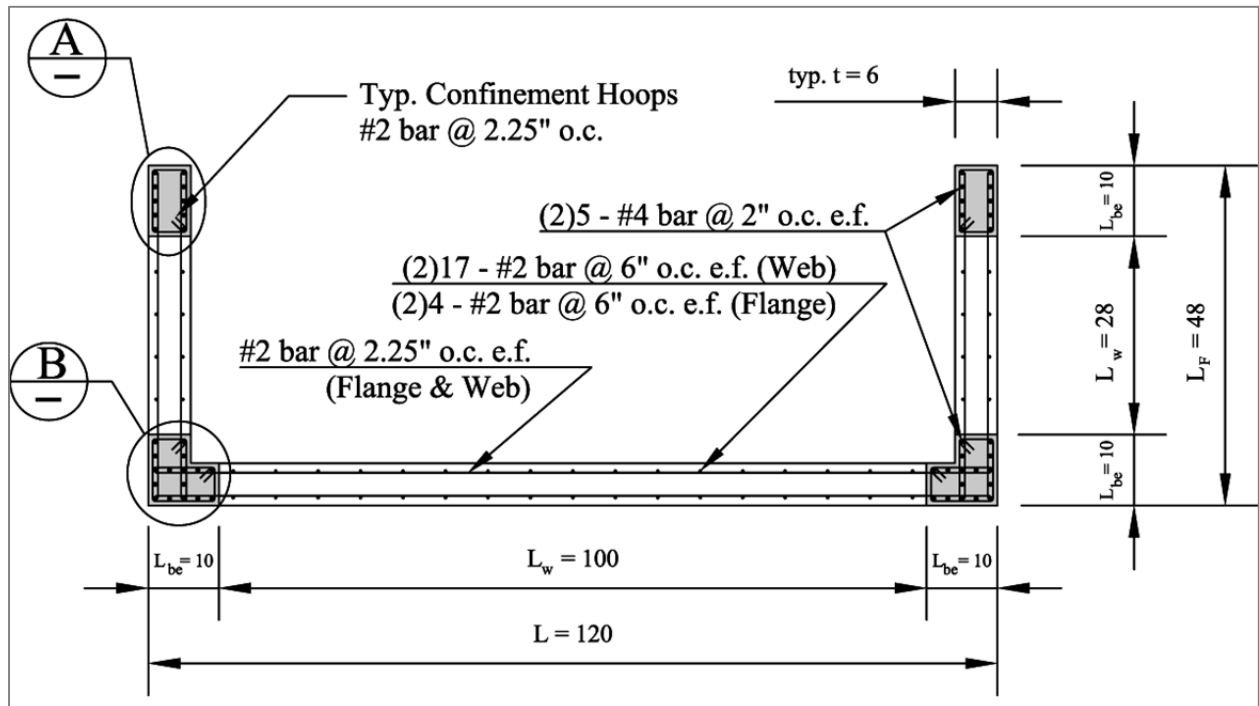
Figure 2.1: Wall 6/7/8 overall wall geometry and reinforcing (dimensions are provided in inches)

To complete the wall designs, horizontal reinforcement was designed to achieve $V_n = 8\sqrt{f_c}A_{cv}$ and boundary element confinement was designed per ACI 318-08. Figure 2.1 shows the reinforcement layout. Figure 2.2 and Figure 2.3 show boundary element details for Wall 6 and Walls 7 and 8, respectively. An error in construction of Wall 6 resulted in failure to place a required hook in the boundary element (Figure 2.2). This error was not expected to significantly affect the response of Wall 6, which was loaded such that the boundary element in question was not subjected to large compressive demands; this error was corrected in construction of Walls 7 and 8 (Figure 2.3), as these walls were loaded in such a way that the boundary element in question was subjected to large compressive demands. An error in construction of Wall 6 also resulted in all boundary element confining reinforcement being spaced vertically at 2.25 in. rather the ACI Code required maximum spacing of 2.0 in.; this error was not corrected in construction of Walls 7 and 8 as it was not expected to significantly affect response and to preserve consistency in specimen design.

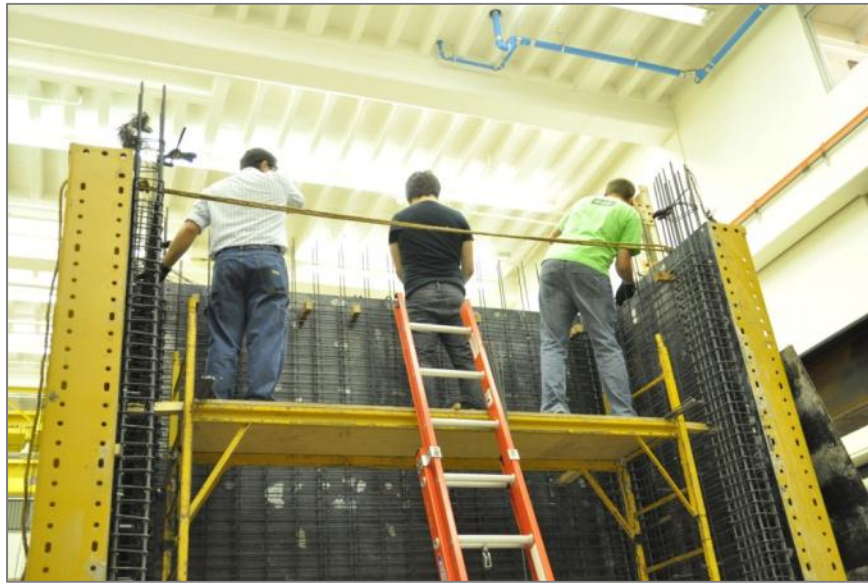
Figure 2.6: Near completion of Wall 8 rebar cage

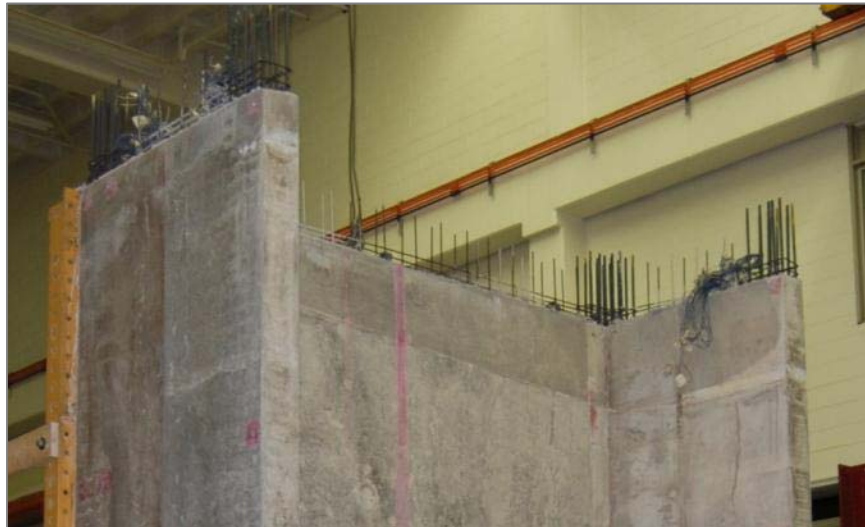
During the casting of Wall 6, a brace for the formwork split after approximately 11 feet of the wall specimen had been poured. Consequently, the casting was completed in two separate pours with a two hour time gap. There was no indication of a cold joint forming, but a line was visible after removing the formwork as shown in Figure 2.9. The wall exhibited a modest amount of segregation but no significant honeycombing. No patchwork was needed.

Figure 2.9: Wall 6 after formwork removal

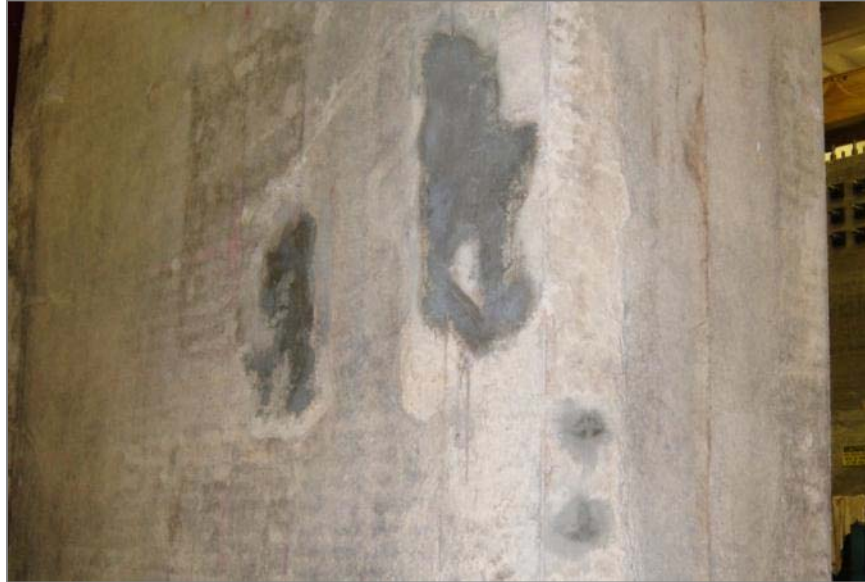
A significant amount of segregation and honeycombing was present after removing the forms of Wall 7. Patchwork was completed in a few areas around the mid-height of the web as shown in Figure 2.10. Additional patching was needed along one flange near the top of the specimen.

Figure 2.10: Wall 7 after patchwork near mid-height of web

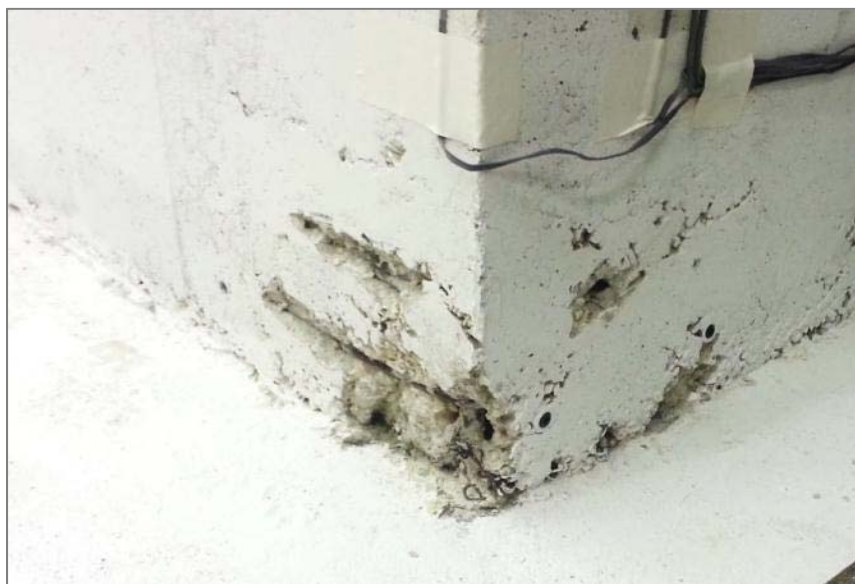
A significant amount of segregation and honeycombing was present on Wall 8 as well as some voids at the bottom of the wall in the corner boundary elements as shown in Figure 2.11. The voids were limited to the cover and did not extend into the confined core of the boundary element. Patchwork was completed using a high-strength grout.

Figure 2.11: Voids in Wall 8 boundary element corner before patchwork

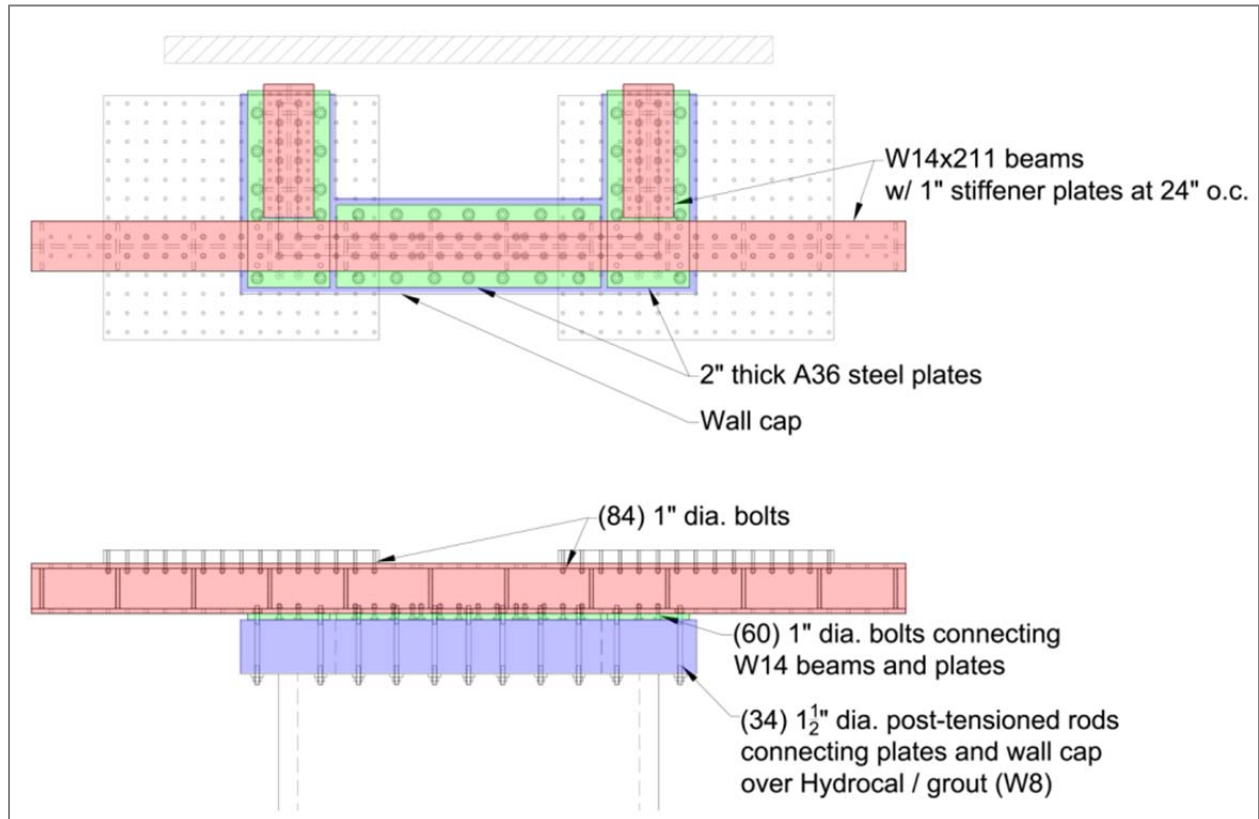
mate the wall specimen cap to the LBCB platens. Three wide flange beams (W14x211) are connected to the LBCB platens using (84) 1" diameter high-strength bolts, each with a clamping force of approximately 40 kips. The beams are connected to 2" thick steel plates using (60) 1" diameter high-strength bolts, each with a clamping force of approximately 40 kips. The plates were countersunk to allow the bolt heads to lay flush with the face of the plate. To complete the connection, the plates are connected to the specimen wall cap using (34) 1.5" diameter steel rods, each with a clamping force of approximately 45 kips. Figure 4.2 diagrammatically depicts the connection beam assembly.

Figure 4.2: Connection beam diagram

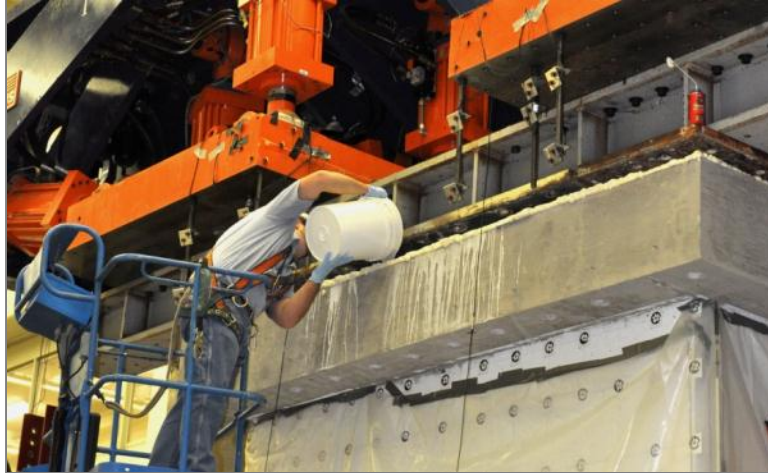
Figure 4.3: Pouring Hydrocal for connection of Wall 7

The connection assembly is attached to the LBCB platens and then lowered down onto a mixture of Hydrocal/grout on specimen wall cap as shown in Figure 4.3. The Hydrocal/grout creates a flat and even surface for uniform transfer of load between the steel plates and wall cap. Hydrocal is a gypsum cement and was used for connection of Wall 6 and Wall 7. A high-strength grout was used in Wall 8. Grout was used on Wall 8 to allow more working time in making the connection. The mix was allowed to cure prior to connecting and post-tensioning the 1.5" diameter steel rods as shown in Figure 4.4. The completed connection is pictured in Figure 4.5.

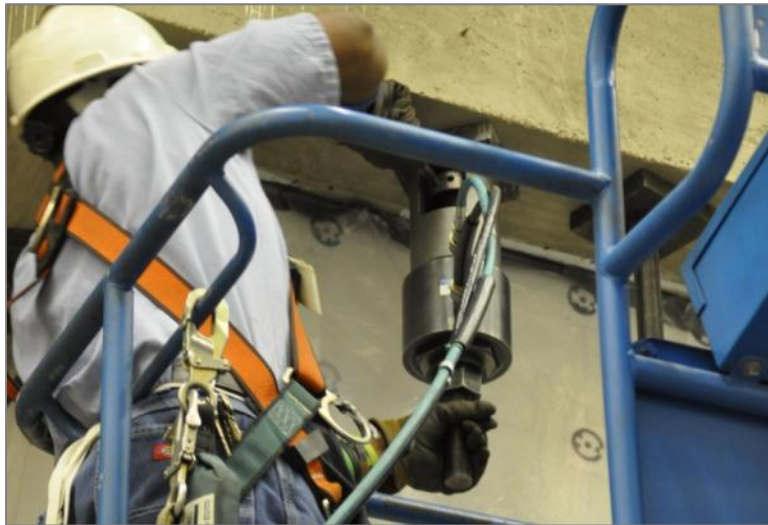
Figure 4.4: Hydraulic tensioning of Wall 8 cap rods

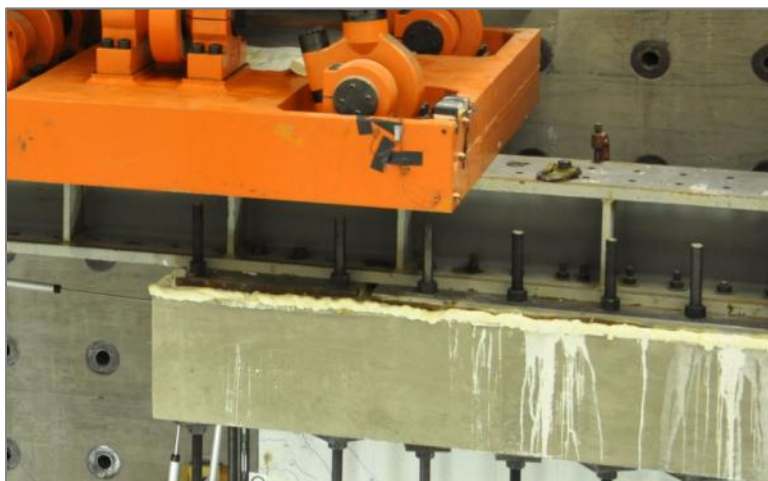
Figure 4.5: Completed connection of Wall 7

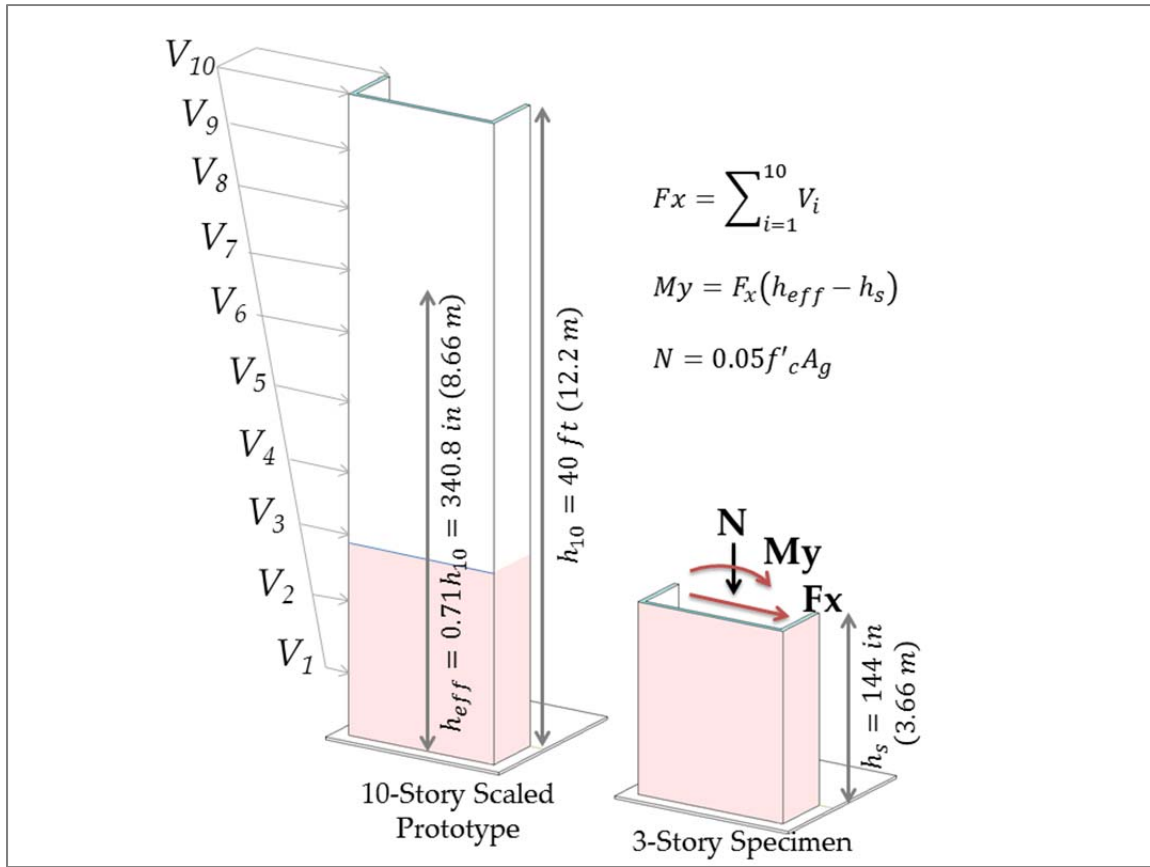
The first C-shaped wall test investigated performance of the test specimen under strong-axis bending. A cyclic unidirectional displacement history was executed with an associated constant axial load and moment representative of the prototype structure shown in Figure 4.8. The axial load was held constant at value of 5% of the gross axial capacity of the wall ($0.05f_cA_g$), which is equal to 306 kips. The overturning moment to shear ratio was held constant at 196.8 in; this follows from the ASCE 7-07 ELF distribution. Two cycles of displacement were completed at each drift level in the X-direction, which corresponded to strong axis bending as shown in Figure 4.9. Maximum displacement demands for displacement cycles were intended to target limit states of concrete cracking, yielding of longitudinal reinforcement, nominal flexural strength, concrete spalling and subsequent damage states. The displacement history is shown in Table 4-3 and Figure 4.10.

Figure 4.8: Wall 6 loading protocol

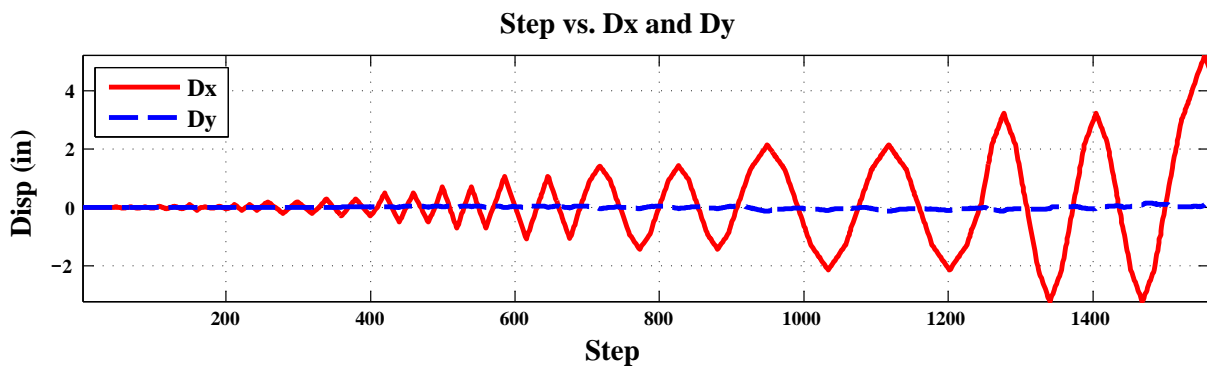
Figure 4.10: Wall 6 plot of displacement history in x- and Y-directions

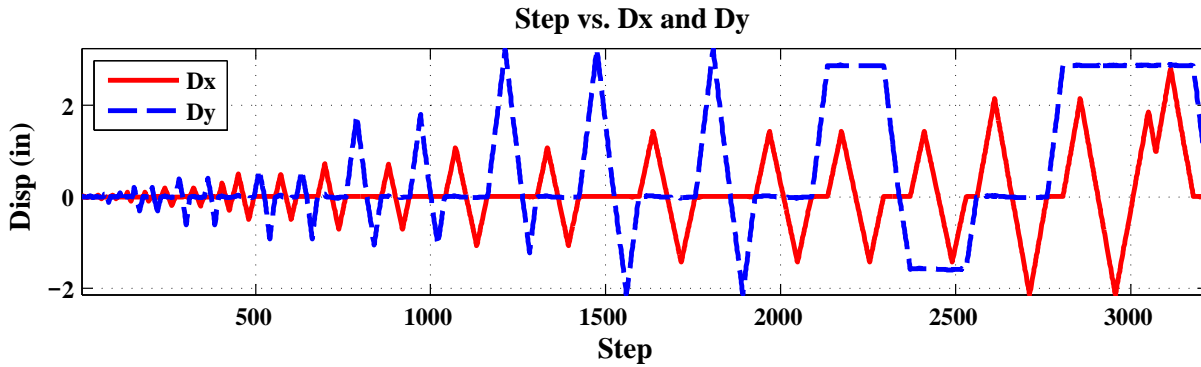
Figure 4.14: Wall 7 plot of displacement history in x- and Y-directions

For the majority of the test, two displacement cycles were completed in each direction at each drift level following the cruciform history shown in Figure 4.12. Following this cruciform history, cycles 1 and 3 displace the wall in the direction of the web of the wall, which is the X-direction and activates strong-axis bending of the wall; cycles 2 and 4 displace the wall in the directions of the flanges, which is the Y-direction and activates weak-axis bending of the wall. Towards the end of the test, the displacement capacity of the loading apparatus was reached in the positive and negative Y-directions. To enable application of increasing demand on the boundary elements of the wall, which are severely loaded under weak-axis / Y-direction loading, the cruciform displacement history was replaced with the bidirectional displacement history shown in Figure 4.13. This displacement pattern consisted of a full displacement cycle in X-direction while maintaining a constant Y-direction displacement. Maximum displacement demands for displacement cycles in both the x- and Y-directions were intended to target limit states of concrete cracking, yielding of longitudinal reinforcement, nominal flexural strength, concrete spalling and subsequent damage states. The displacement history is shown in Table 4-4 and Figure 4.14.

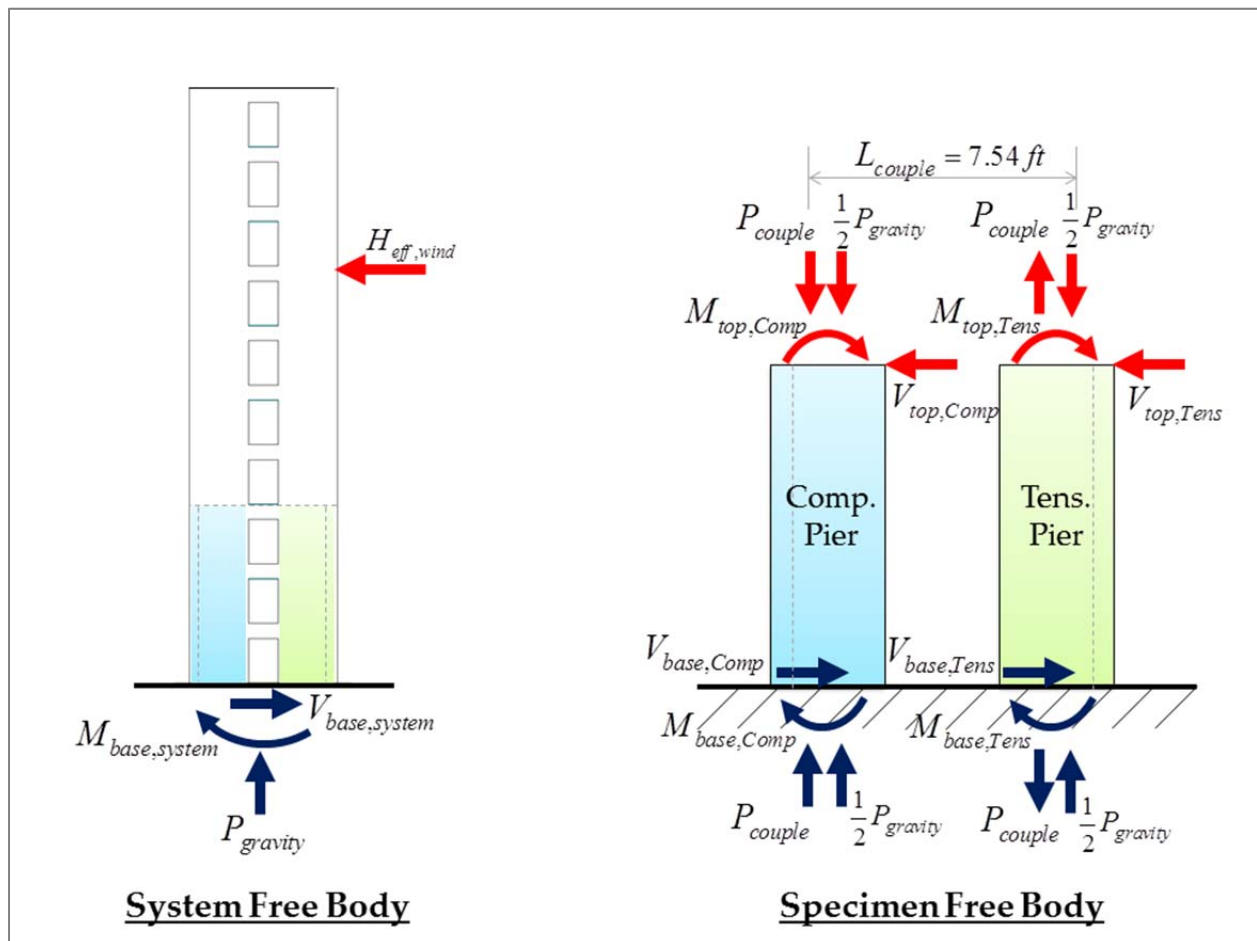
It should be noted that the laboratory test specimen represents the bottom three stories of one C-shaped wall pier *without coupling beams*. Without coupling beams, the demands that develop in a C-shaped wall in the coupled core-wall system cannot be simulated in the laboratory specimen over the entire three-story height of the laboratory specimen. Consequently, demands were applied at the top of the laboratory specimen to achieve representative demands in the critical first story of the specimen. This is illustrated in a free-body diagram of the coupled walls individual and system demands in Figure 4.16.

Figure 4.16: Coupled core wall free body diagram

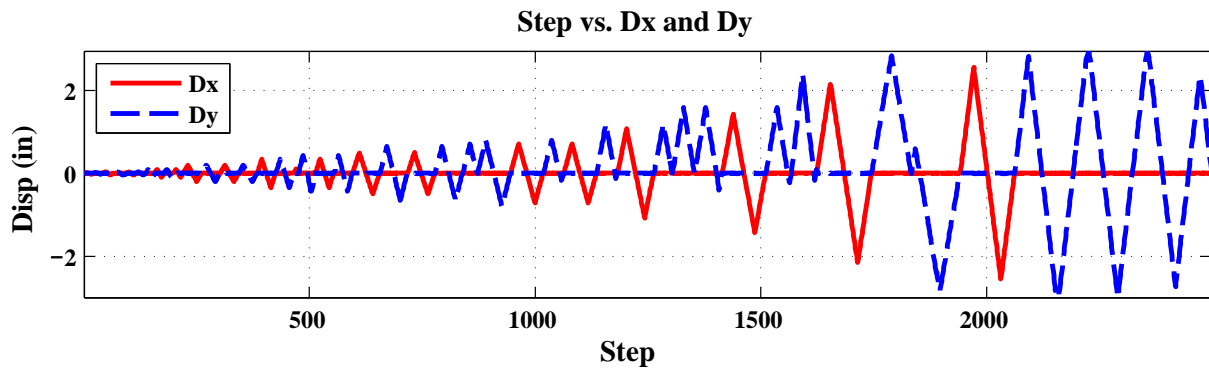
Figure 4.17: Wall 8 plot of displacement history

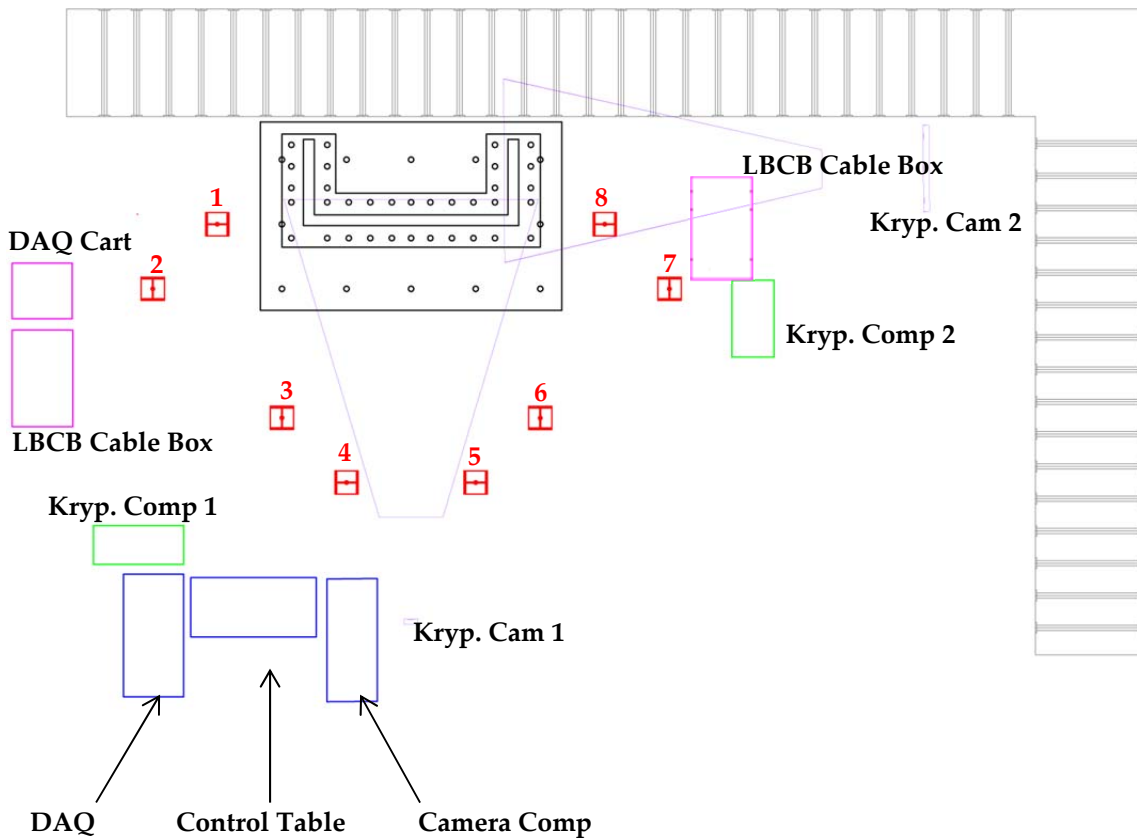
Figure 5.1 provides a plan view of the laboratory set-up for the C-shaped wall experiment. There are eight reference columns installed around the wall specimen to provide a fixed location to attach absolute displacement transducers as well as a place to mount still cameras used for photogrammetry. The diagram illustrates the location and orientation of the two Nikon Metrology/Krypton cameras, in addition to their field-of-view indicated by a trapezoidal region. Also shown are the positions of the data acquisition (DAQ) hardware cart and the computer stations set up for operating controls and monitoring the various data collection systems.

Figure 5.1: Plan View Diagram of Experimental Test Set-up

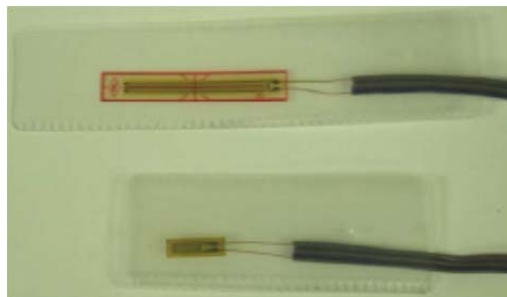
Each C-shaped wall was heavily instrumented with quarter bridge strain gauges. Two types of Texas Measurements Inc (TMI) gauges were utilized: high-elongation 5mm gauges were affixed to the reinforcing bars before tying the rebar cage and casting the concrete, and large general purpose 30mm gauges were applied to the concrete surface after curing. These gauge types are shown in Figure 5.2.

Figure 5.2: Concrete surface gauge (above) and steel reinforcement gauge (below)

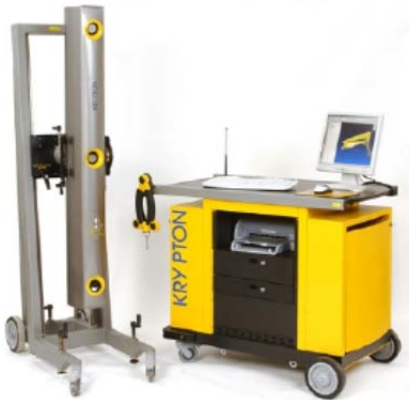
The Krypton system has three cameras mounted to a fixed unit and uses triangulation principles to measure the position of infrared signals emitted by light emitting diodes (LED) mounted to the wall specimen. The Nikon Metrology/Krypton camera and data acquisition unit can be seen in Figure 5.10.

Figure 5.10: Nikon Metrology/Krypton K600 Optical CMM System

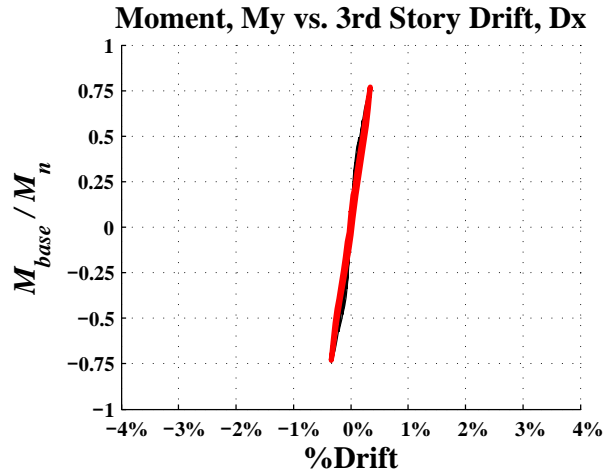
The cracking pattern developed primarily in the cycles up to yielding. Cracking was initiated by flexural cracks in the first and second stories of the flanges. Inclined shear cracking then developed shortly after as well as additional uniformly spaced flexural cracks along the boundary elements in the web. The 0.35% drift cycle marked yielding of multiple #4 bars in the boundary elements in each direction as well as #2 bars in the flanges.

Figure 6.3: Wall 6 substantial yield hysteresis

Figure 6.4: Wall 6 substantial yield photos

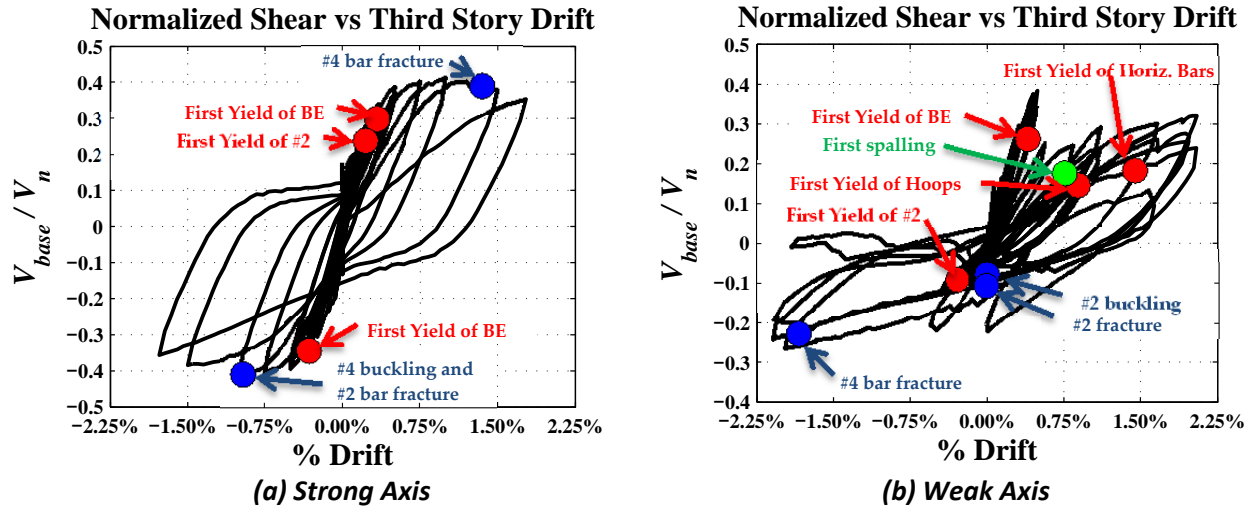
Figure 8.1: Wall 8 load deformation with key points of history

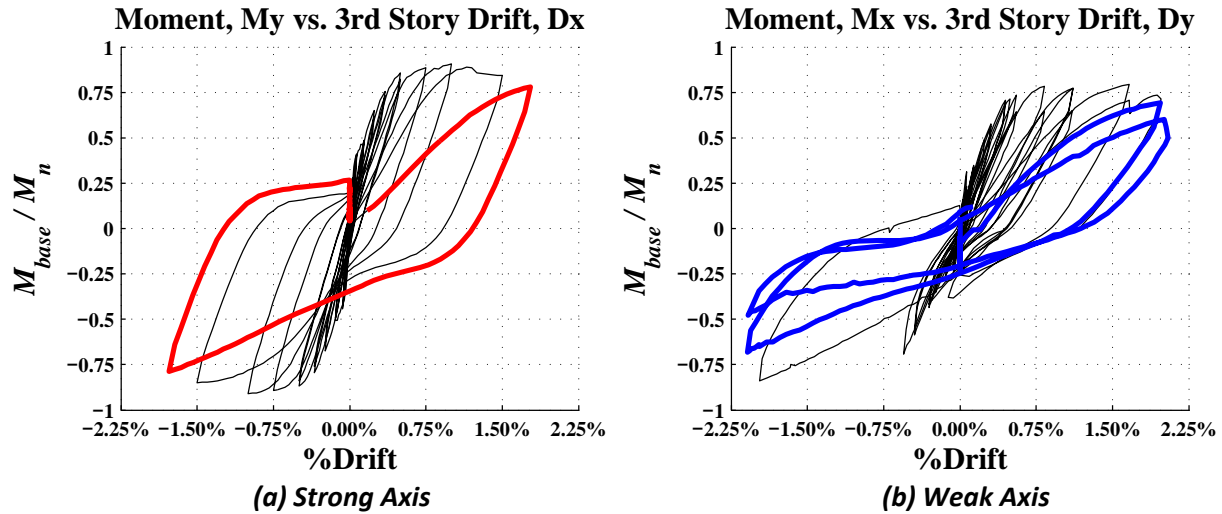
Figure 8.10: Wall 8 bar buckling and rupture hysteresis

Figure 8.11: Wall 8 bar buckling and rupture photos

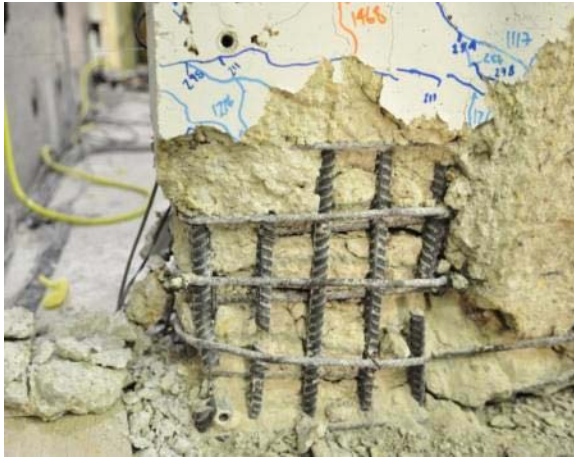
(a) West flange toe

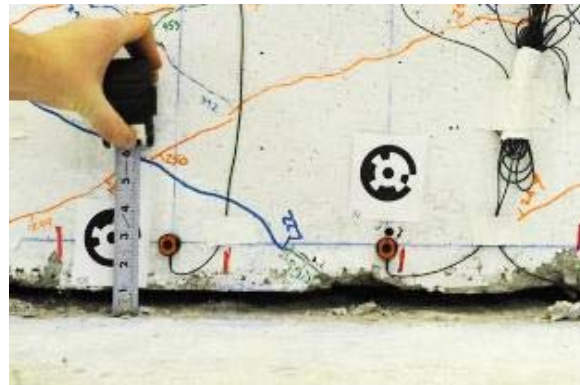
For all three tests, the majority of longitudinal #2 bars in the web and flanges of the walls had ruptured at the footing and wall interface. Rupture of this reinforcement resulted in a large separation (i.e. wide crack) between the wall and footing. For the flanges, the separation between the wall and footing was most pronounced when the wall was subjected to displacement demands in the X-direction activating strong-axis bending; for Wall 7, measured separation of the East flange and footing exceeded one half inch (Figure 9.3(a)). For the web of the C-shaped walls, the separation between the wall and footing was most pronounced when the wall was subjected to displacement demands in the negative Y-direction. For Wall 8, displacement in the negative Y-direction was accompanied by application of a tensile axial loading and the separation between the wall and footing exceeded one inch (Figure 9.3(b)).

(b) Wall 8 web separation

Figure 9.3: Interface separation at base

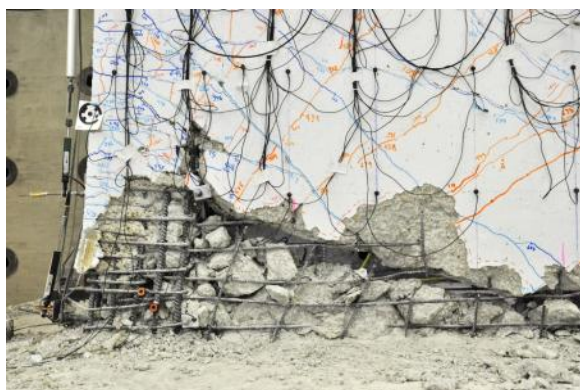
For each test, web sliding was also considered to result in separation between the corner boundary element and the interior of the web of the C-shaped wall. The larger drift demands employed in the unidirectional Wall 6 test exacerbated this separation resulting in a large inclined opening in the web and the rupturing of horizontal reinforcing across this interface as shown in Figure 9.7(a). The separation was also present in Wall 7 and 8 although not as pronounced as shown in Figure 9.7(b).

(a) Wall 6

Figure 9.7: boundary element and web separation

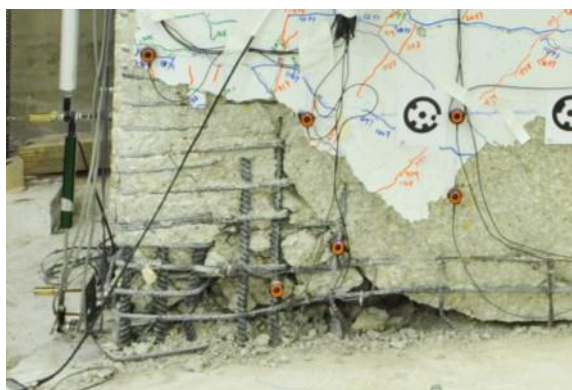
(b) Wall 8
