**EXPERIMENTAL TESTING OF CAST-IN-PLACE SEISMIC RESISTANT
UNBONDED POST-TENSIONED
SPECIAL REINFORCED CONCRETE WALLS**

**Report to
Charles Pankow Foundation
RGA#3-10**

ATLSS Report No. 14-07

December 2014

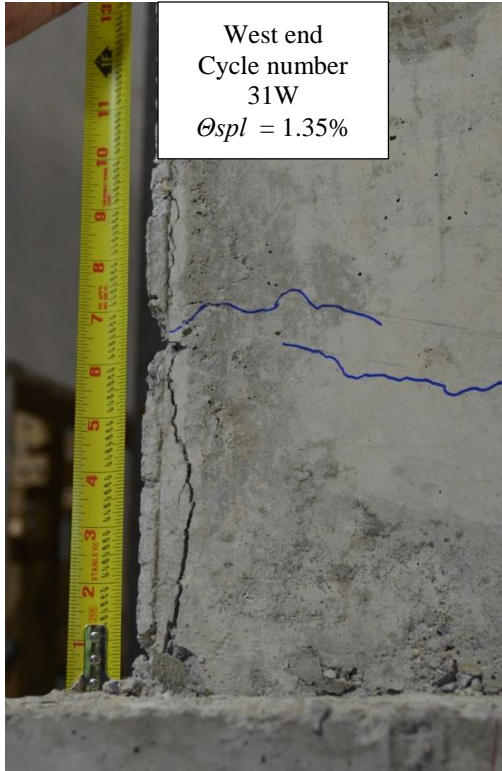
Figure 4-24 Initiation of observed spalling during Load Step 11, Cycle 31 Wall 1

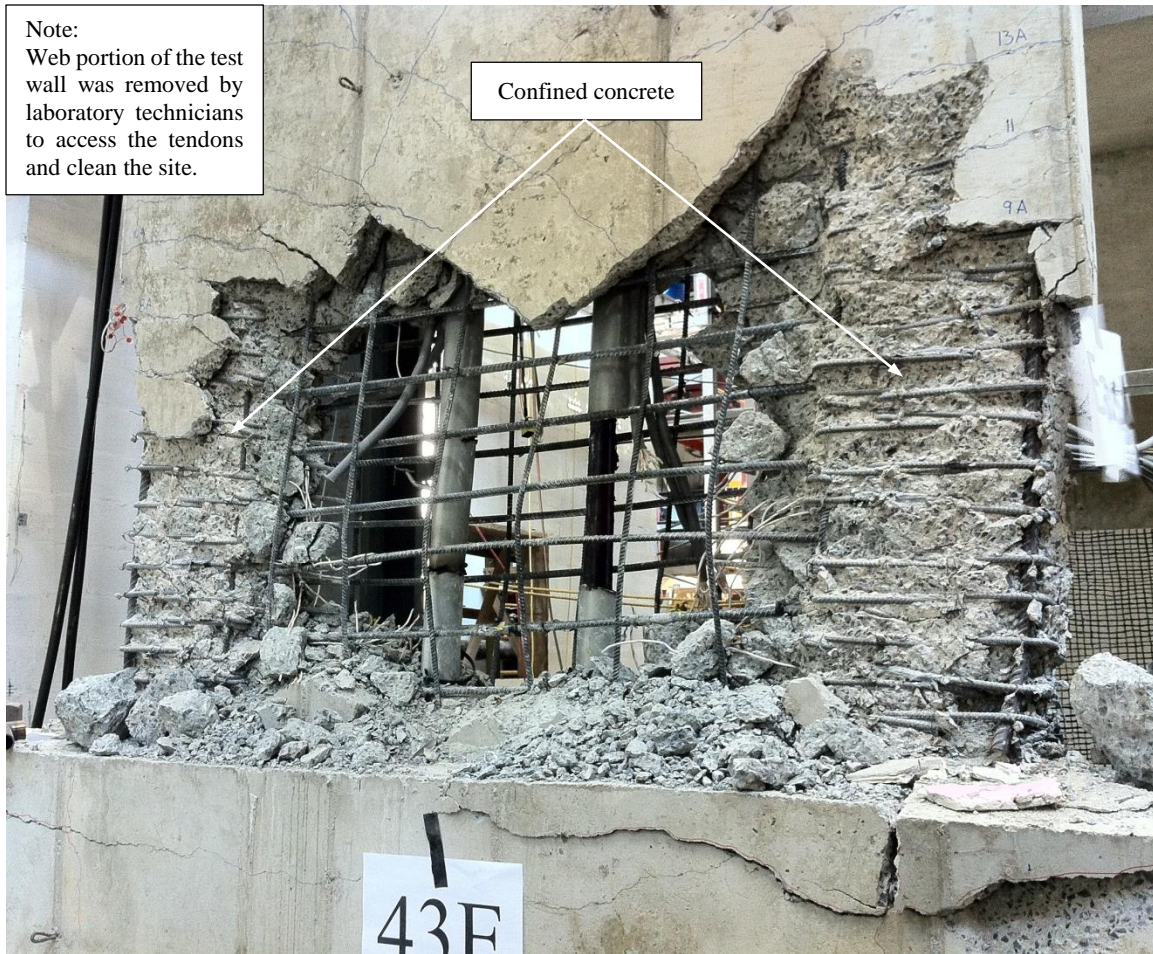
Figure 4-37 Confined concrete on the flange sections of Wall 1

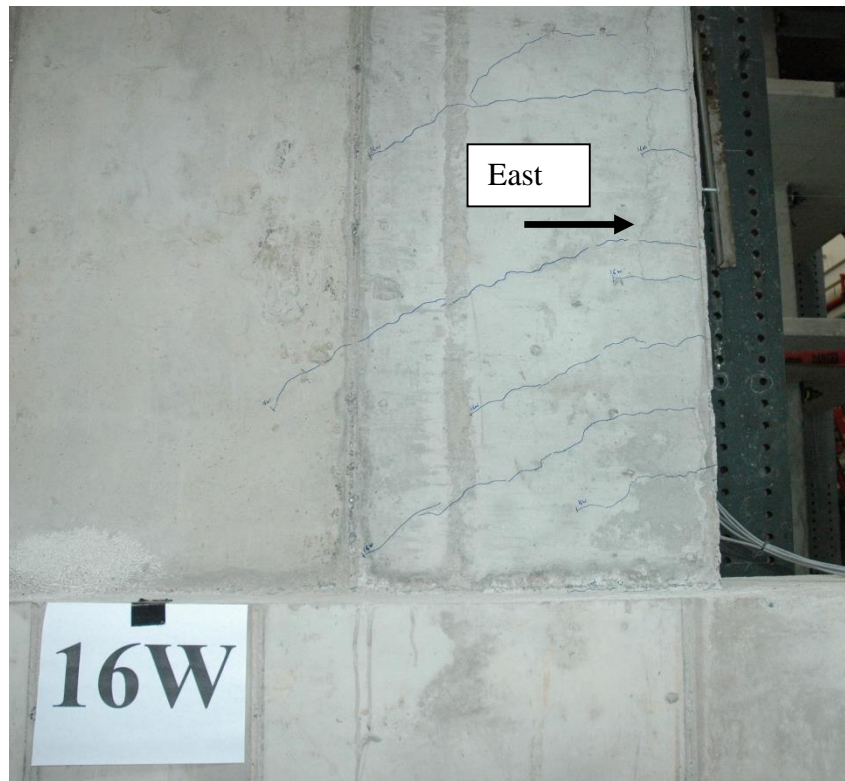
Figure 4-49 Photograph of observed initiation of concrete cracking on the East side Wall 2

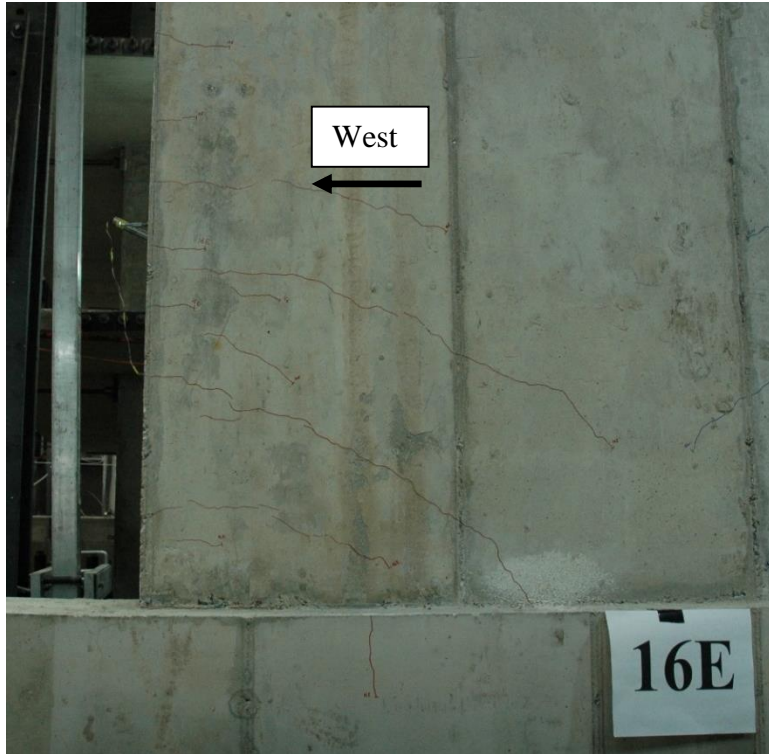
Figure 4-50 Photograph of observed initiation of concrete cracking on the West side Wall 2

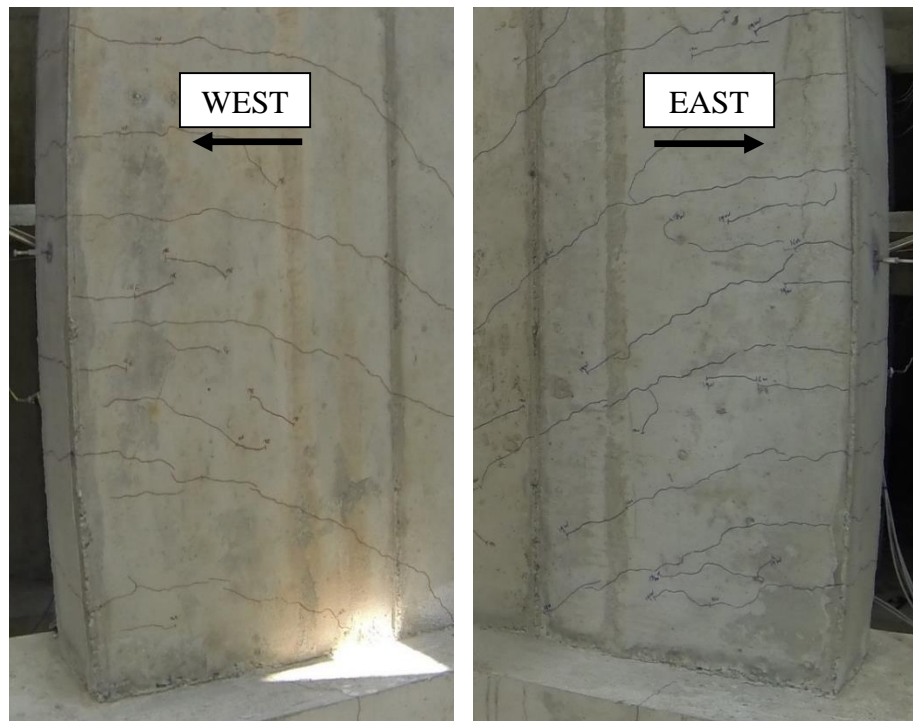
Figure 4-54 Photographs of observed wall conditions at the end of Cycle 19E Wall 2

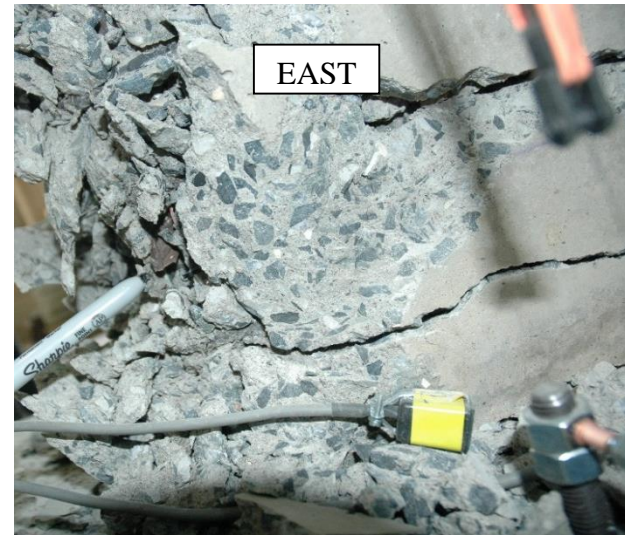
Figure 4-61 Photographs of observed fracture of longitudinal steel reinforcement at Cycle 39W Wall 2

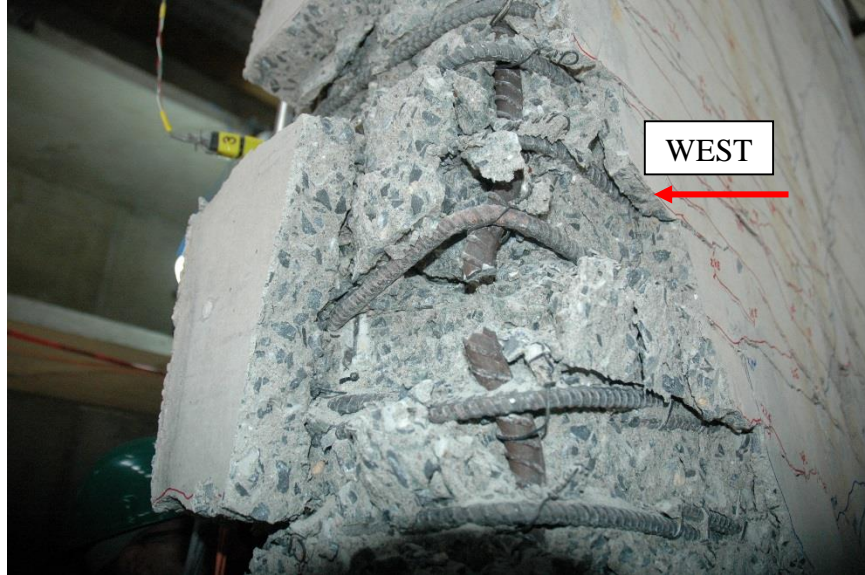
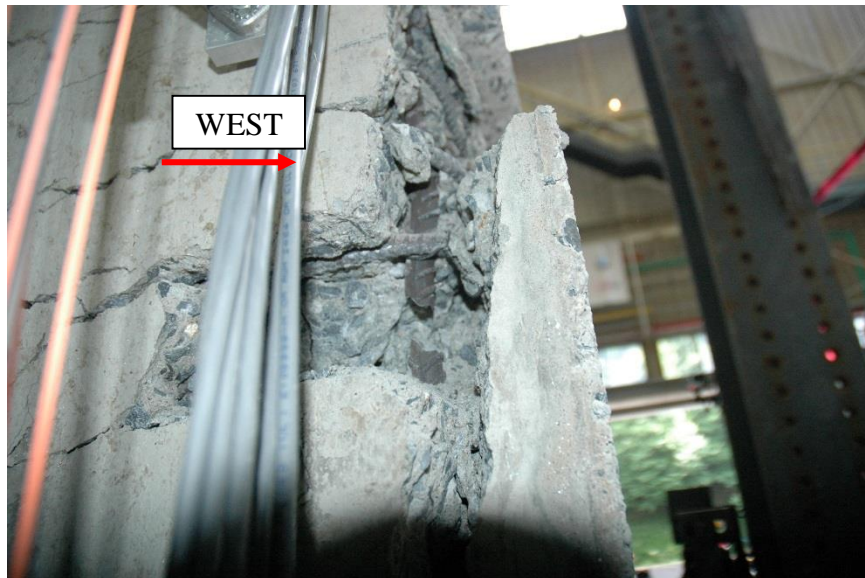
Figure 4-63 Photographs of observed fracture of longitudinal steel reinforcement at Cycle 39E Wall 2

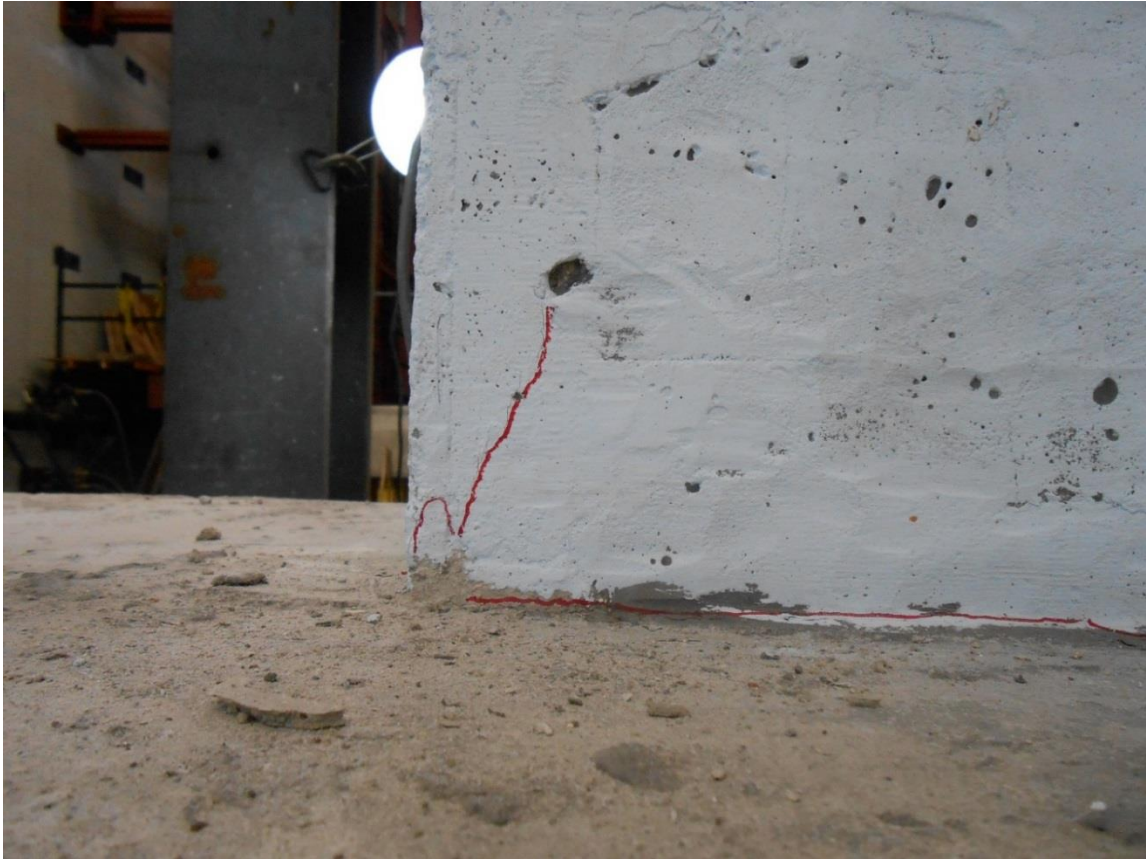
Figure 4-78 Photograph of observed splitting crack at Cycle 16W on the West side Wall 3

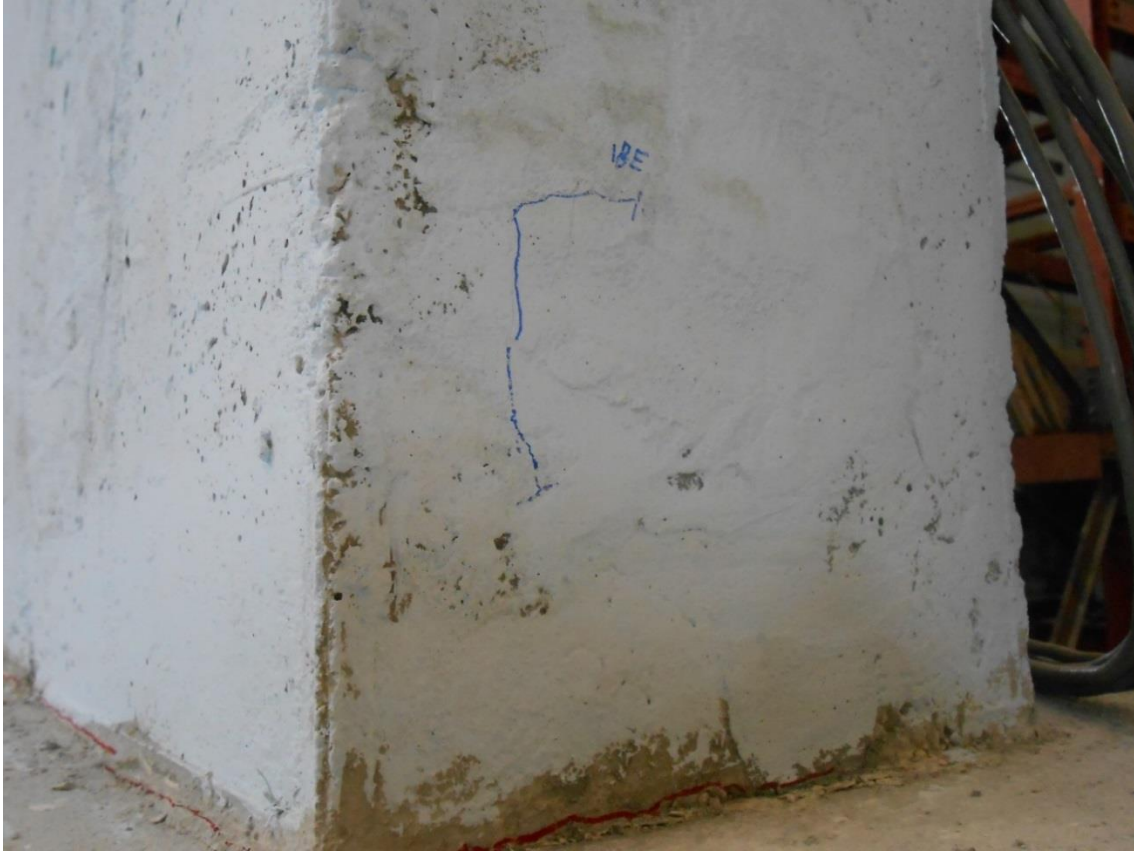
Figure 4-79 Photograph of observed splitting crack at Cycle 18E on the East side Wall 3

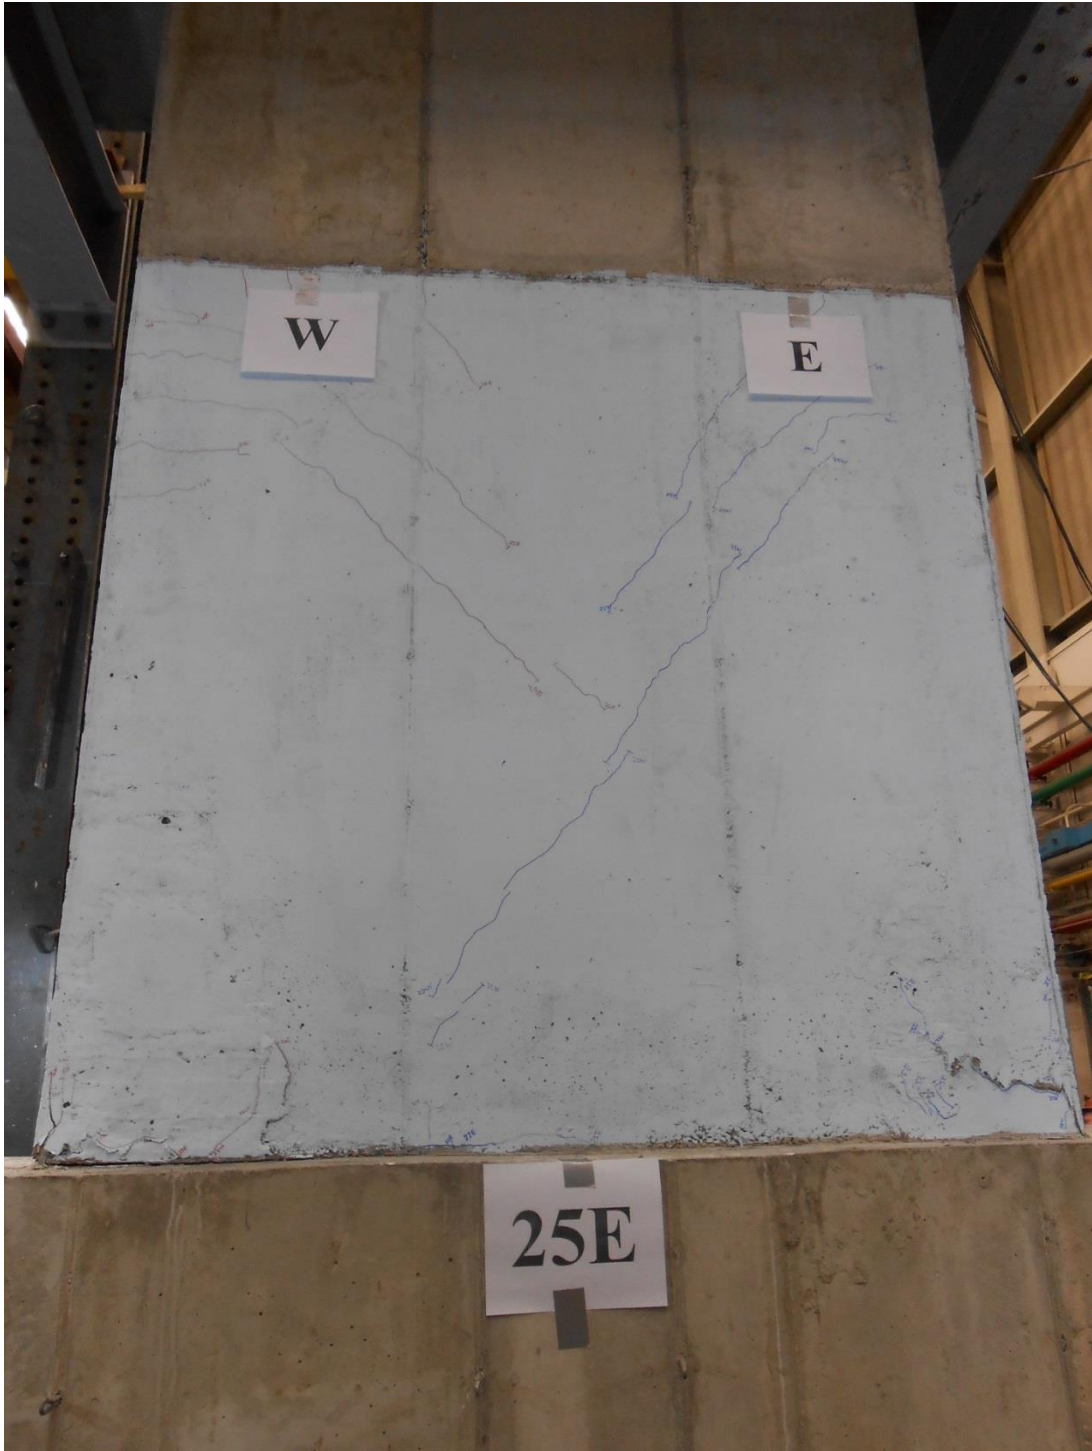
Figure 4-83 Photographs of observed diagonal cracks at Cycle 25E on the West side Wall 3

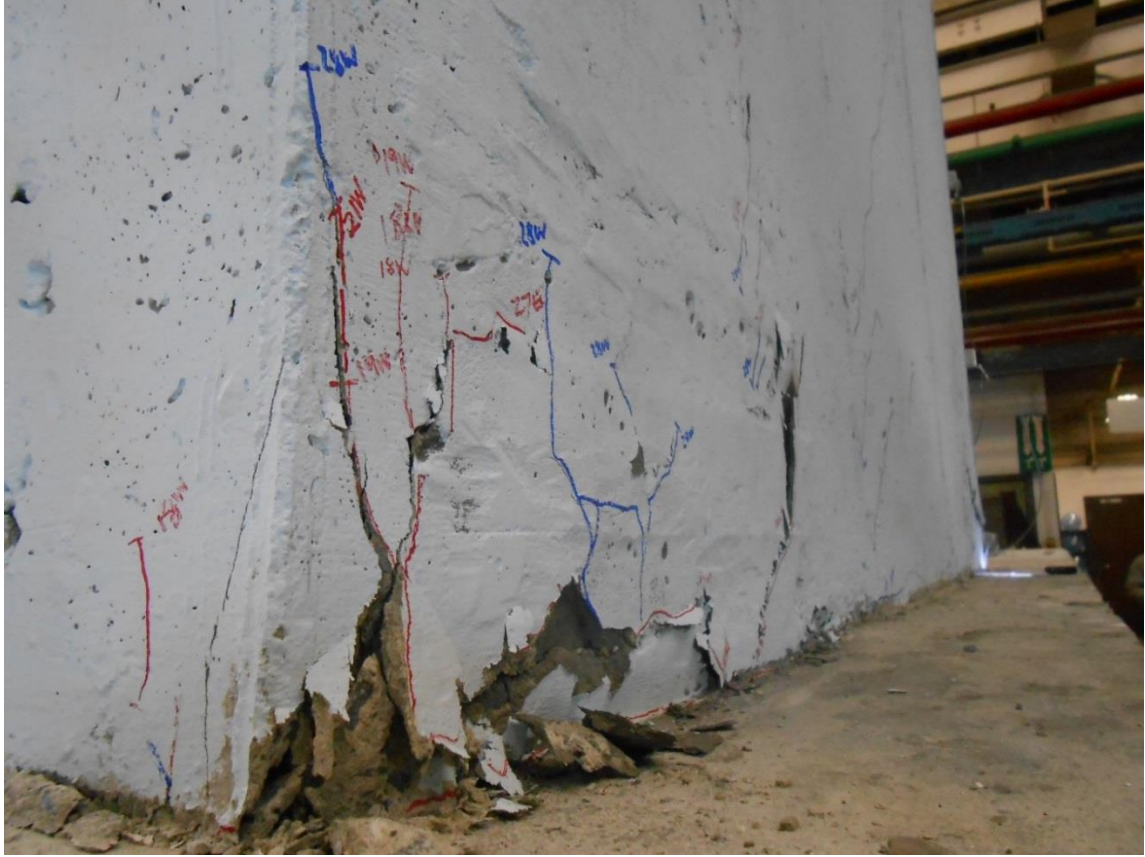
Figure 4-86 Photograph of observed concrete spalling at Cycle 28W on the West side Wall 3

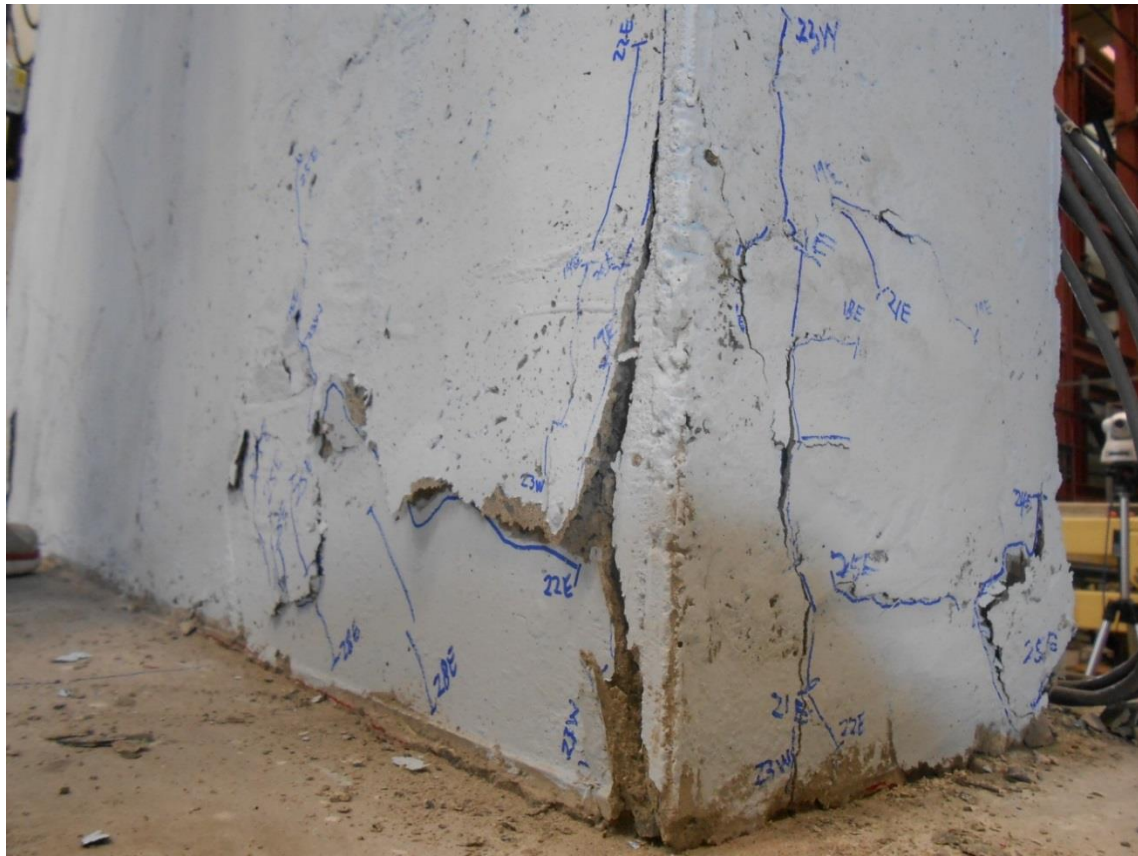
Figure 4-87 Photograph of observed concrete spalling at Cycle 28E on the West side Wall 3

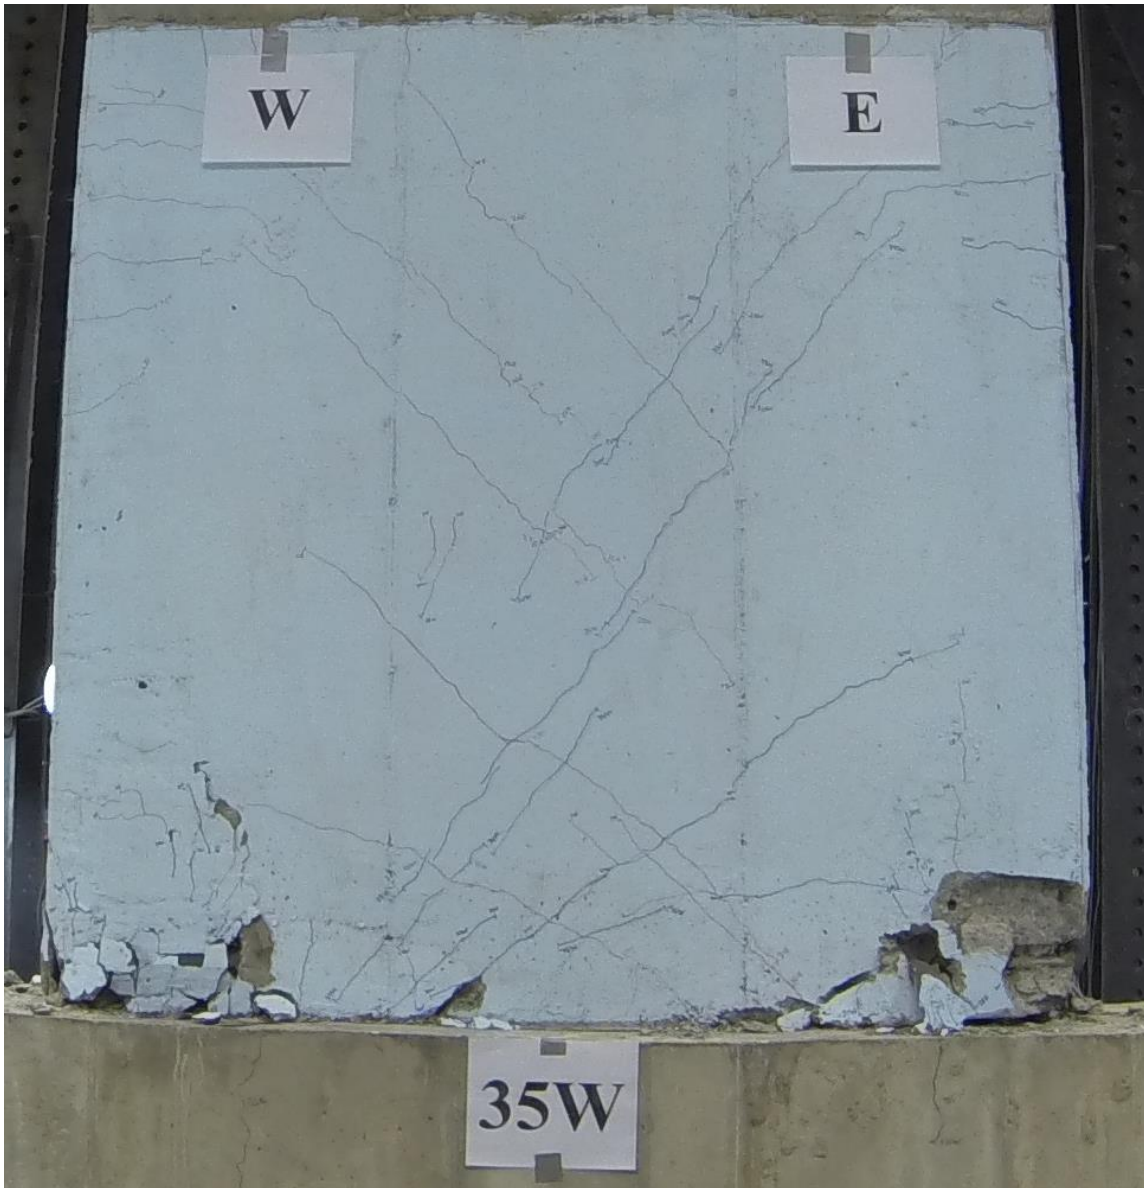
Figure 4-93 Wall condition at the peak of Cycle 35W on the South side Wall 3

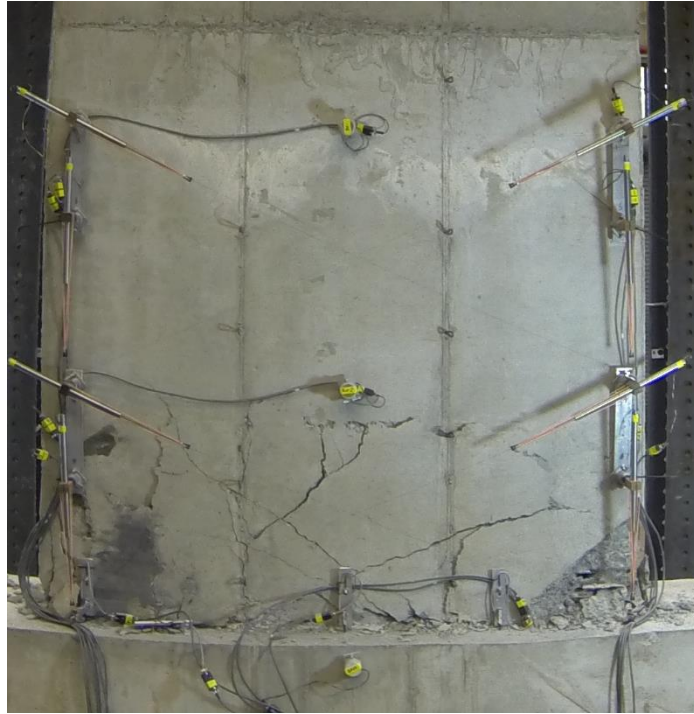
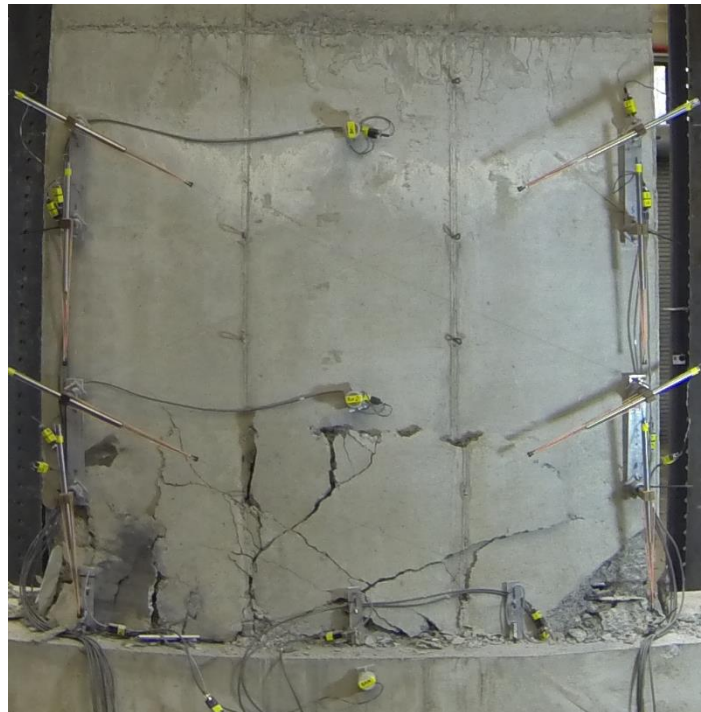
Figure 4-98 Wall conditions at Cycle 35E at North side: (a) at the peak load, (b) at the end of load cycle
