Cyclic Inelastic Behavior of C-Shaped Composite Plate Shear Walls/Concrete Filled (C-PSW/CF)

(CPF Research Grant # 06-16)

**Cyclic Inelastic Behavior of C-Shaped Composite Plate Shear
Walls/Concrete Filled (C-PSW/CF)**

Final Report

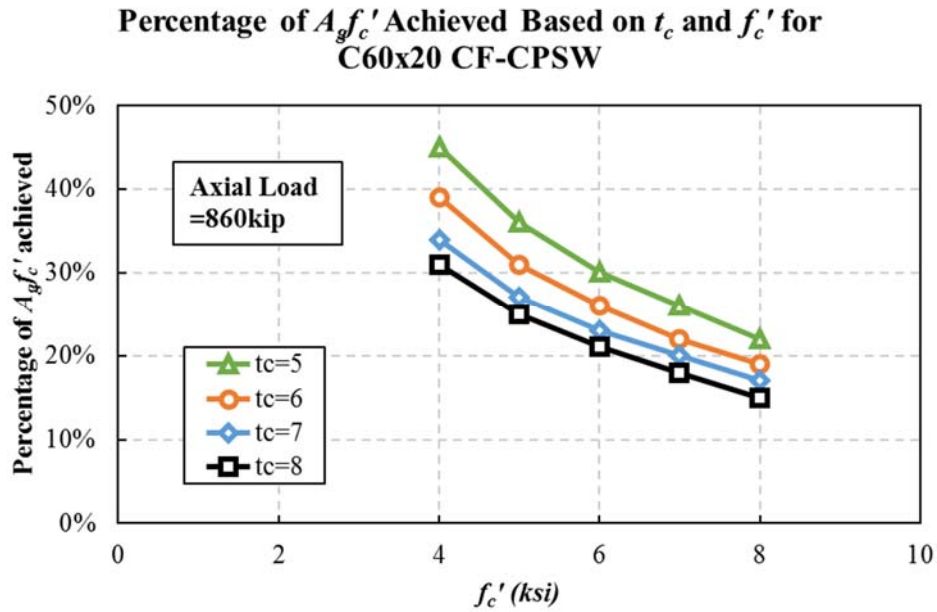
Figure 2-5. Percentage of axial load achieved for C60x20 C-PSW/CF based on t_c and f_c'

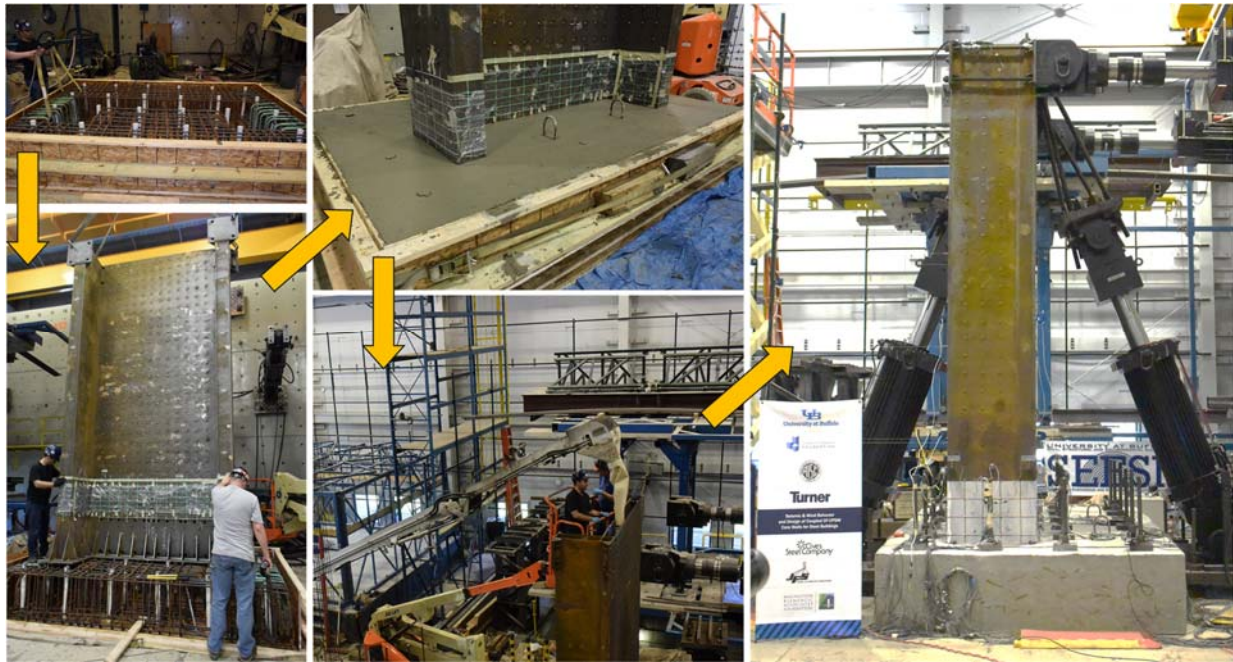
Figure 3-1. Construction sequence of specimens

For each one of the specimens, the formwork for the concrete footing was first constructed. PVC pipes were placed inside the footing on a $2ft.$ center-to-center grid at the locations where DYWIDAG bars were to be later used to connect the specimens to the SEESL strong floor. The reinforcing cage of the foundation was tied outside the formwork and then placed in the formwork. Then the empty module of the wall was positioned into the formwork, clearing the reinforcing bar cages. Additional #10 bars were then ran through the wall's flange (in pre-drilled holes) to achieve continuity of the horizontal reinforcement in the cage in the East-West direction. The pre-drilled holes on the flange through which the #10 bars passed were sealed to prevent the flow of wet concrete between the wall and the foundation.

For Specimen C1, the concrete of the foundation and wall was poured separately and on different days. As it was mentioned before, the strength of the concrete poured in the wall had to be monitored closely in order to not exceed the target strength of $4ksi$, but a stronger concrete for the foundation was acceptable.

By contrast, in preparation of Specimen C2, the concrete of the foundation and wall parts were poured within only a few days of each other; all remaining aspect of test set-up and instrumentation assembly for the test setup preparation were completed following the above sequence.

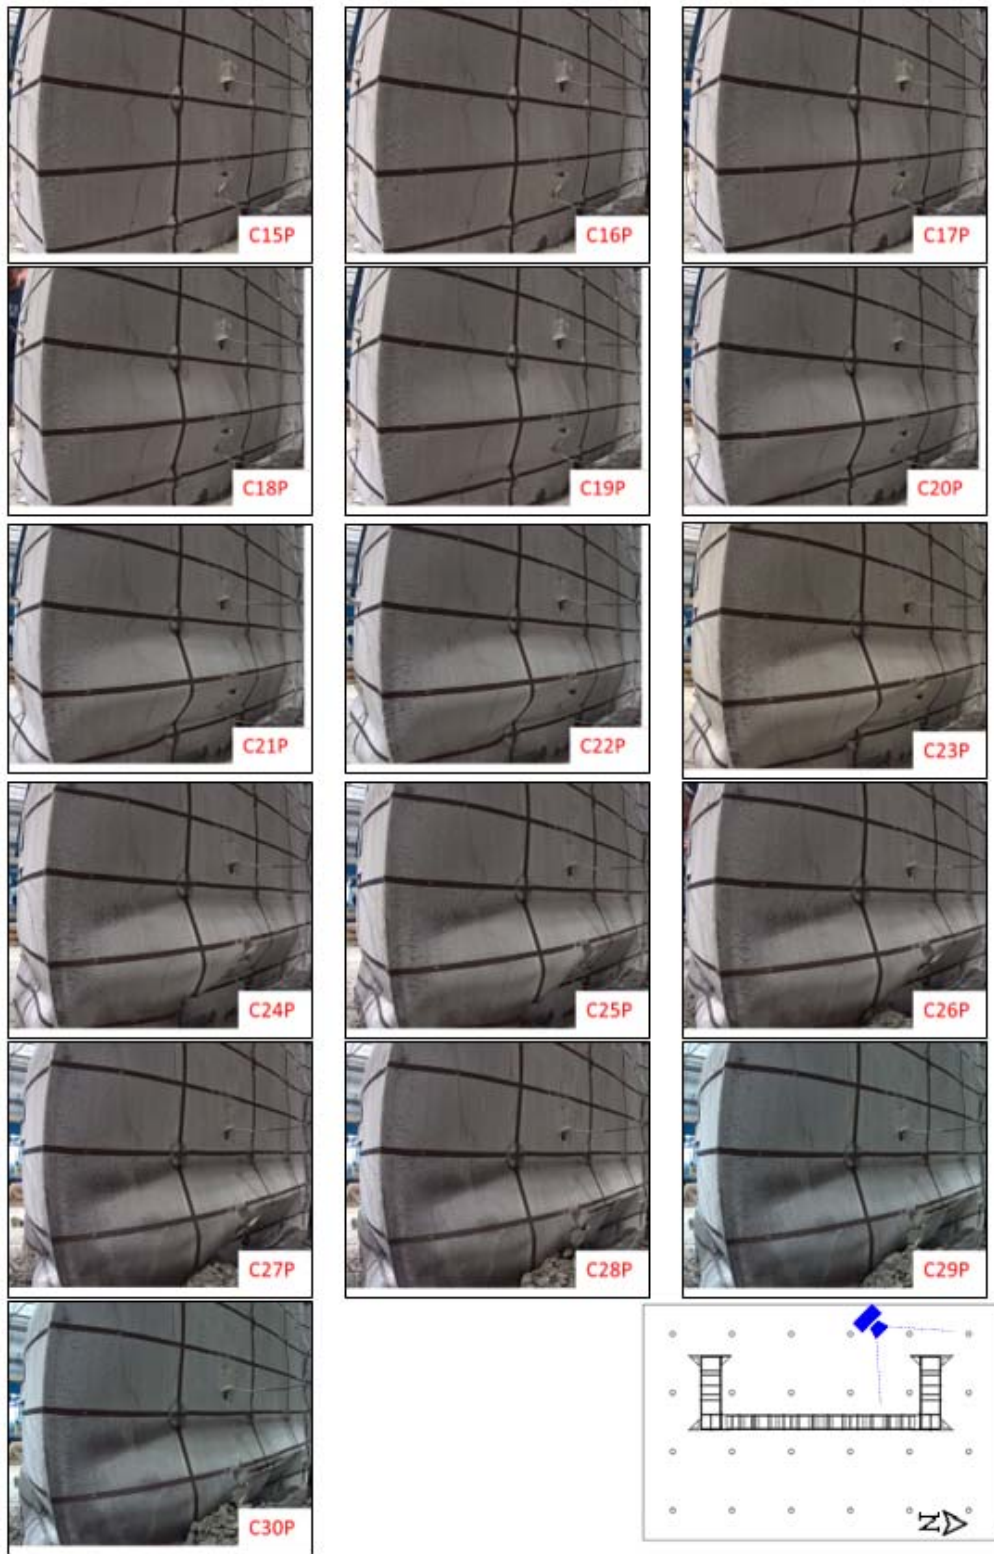
Figure 3-10. South-West views of the North Web of Specimen C1 at positive peaks

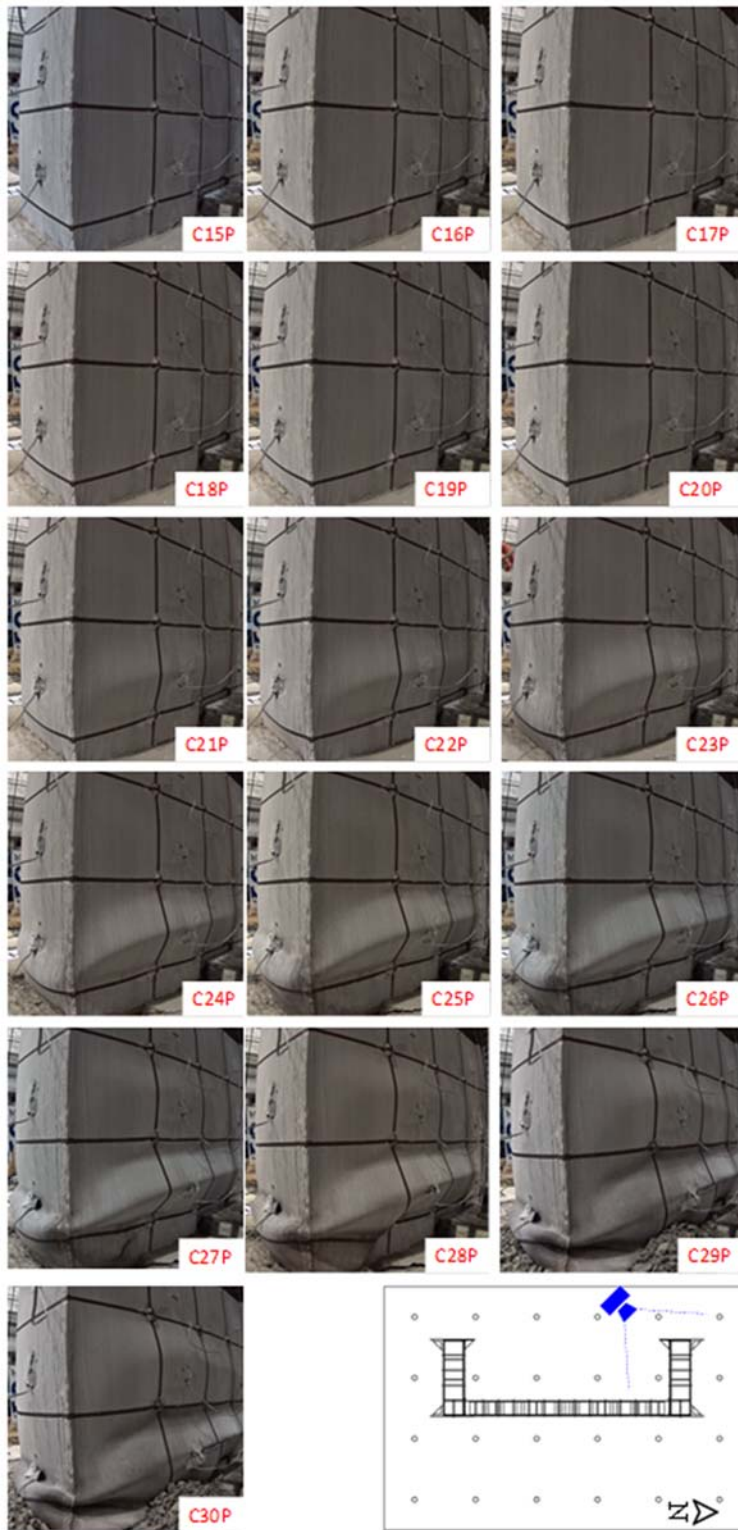
Figure 3-18. South-West views of the North Web of Specimen C2 at positive peaks

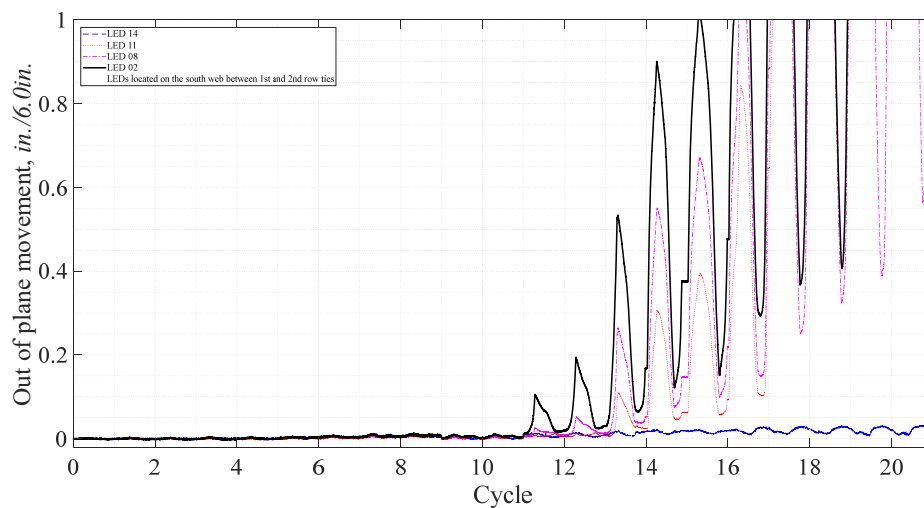
Figure 3-45. Out-of-plane movement of LEDs 14, 11, 08, and 02 located on the web of Specimen C2

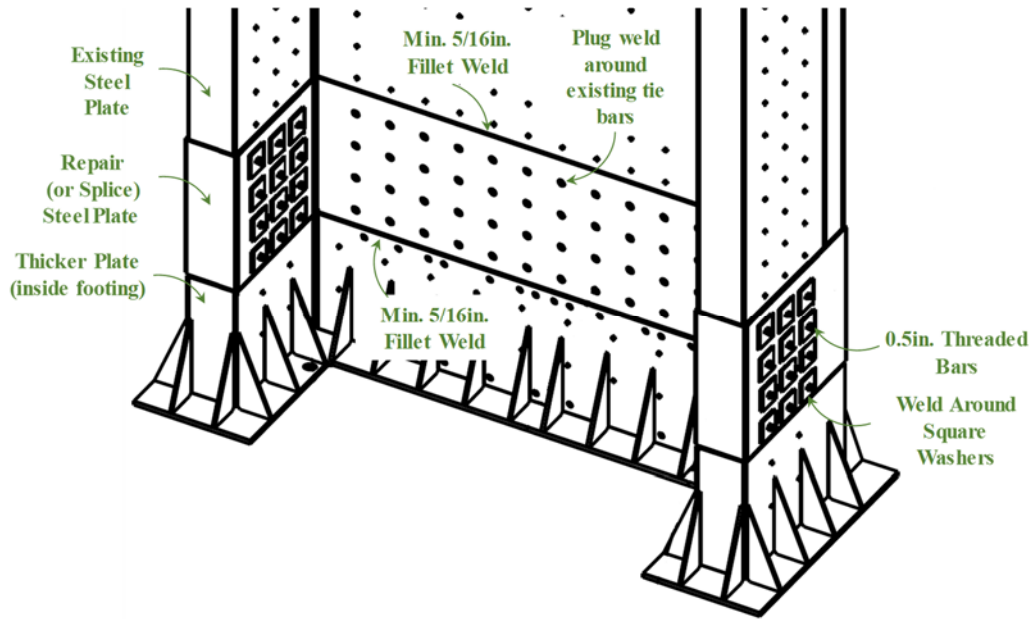
- Filling the empty space between the splice plates with self-consolidating concrete that could easily flow through voids without the need for vibrations.

Figure 4-1. Repair concept for the C2 Specimen

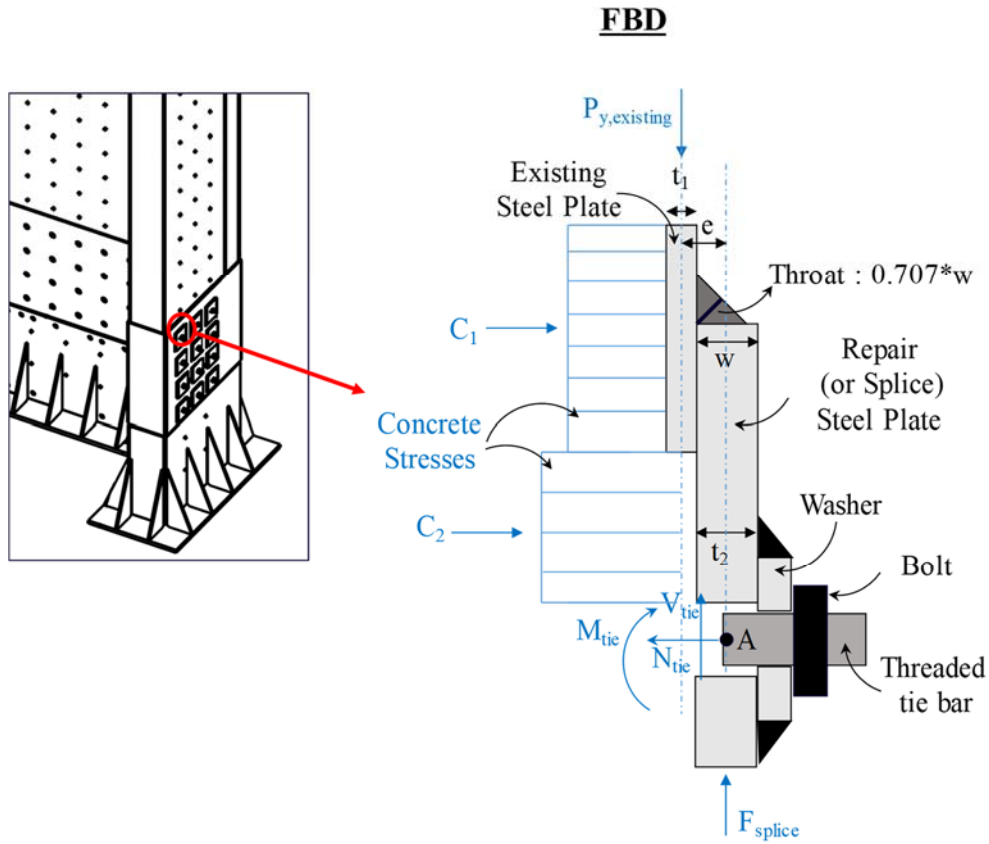
Figure 4-2. Free body diagram of existing and splice plates load transfer

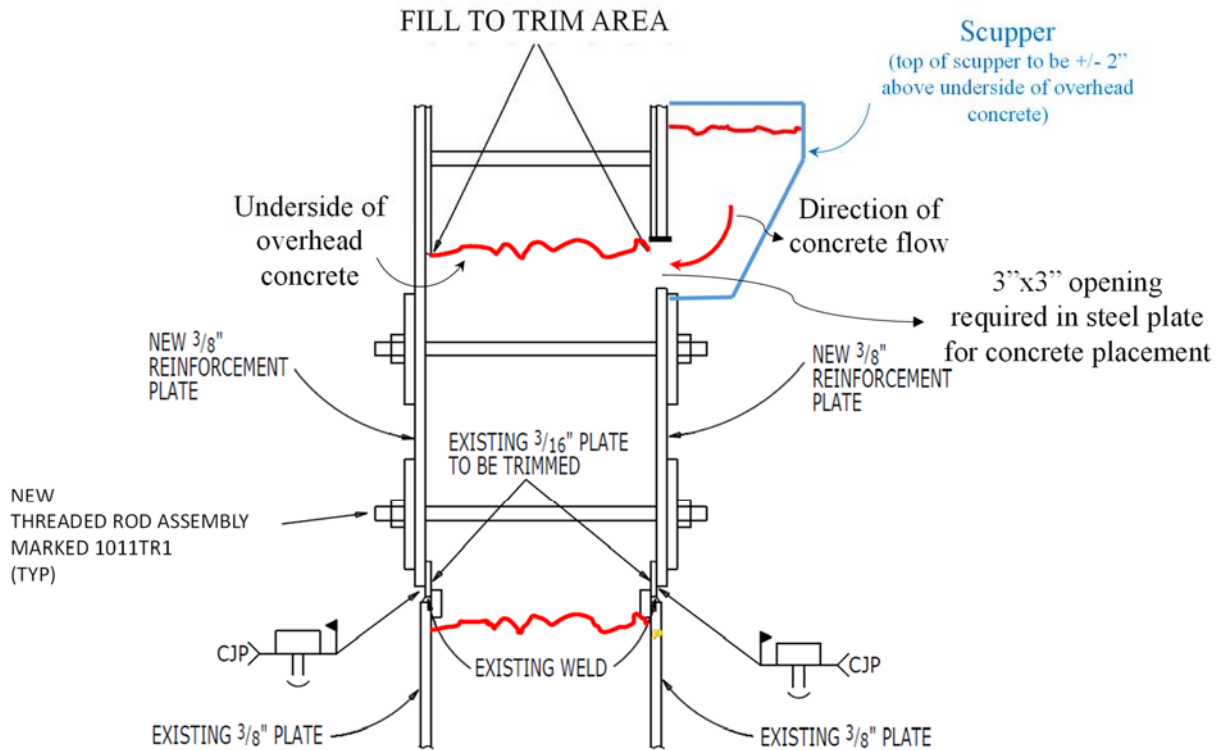
the top level of the chipped concrete on the far ends of the splice plates was used as indicated that the concrete filled the void up to the top (to complement, this was also checked by passing fingers through the scupper holes as far as could reach).

Figure 4-3. Scupper attachment and direction of concrete flow.

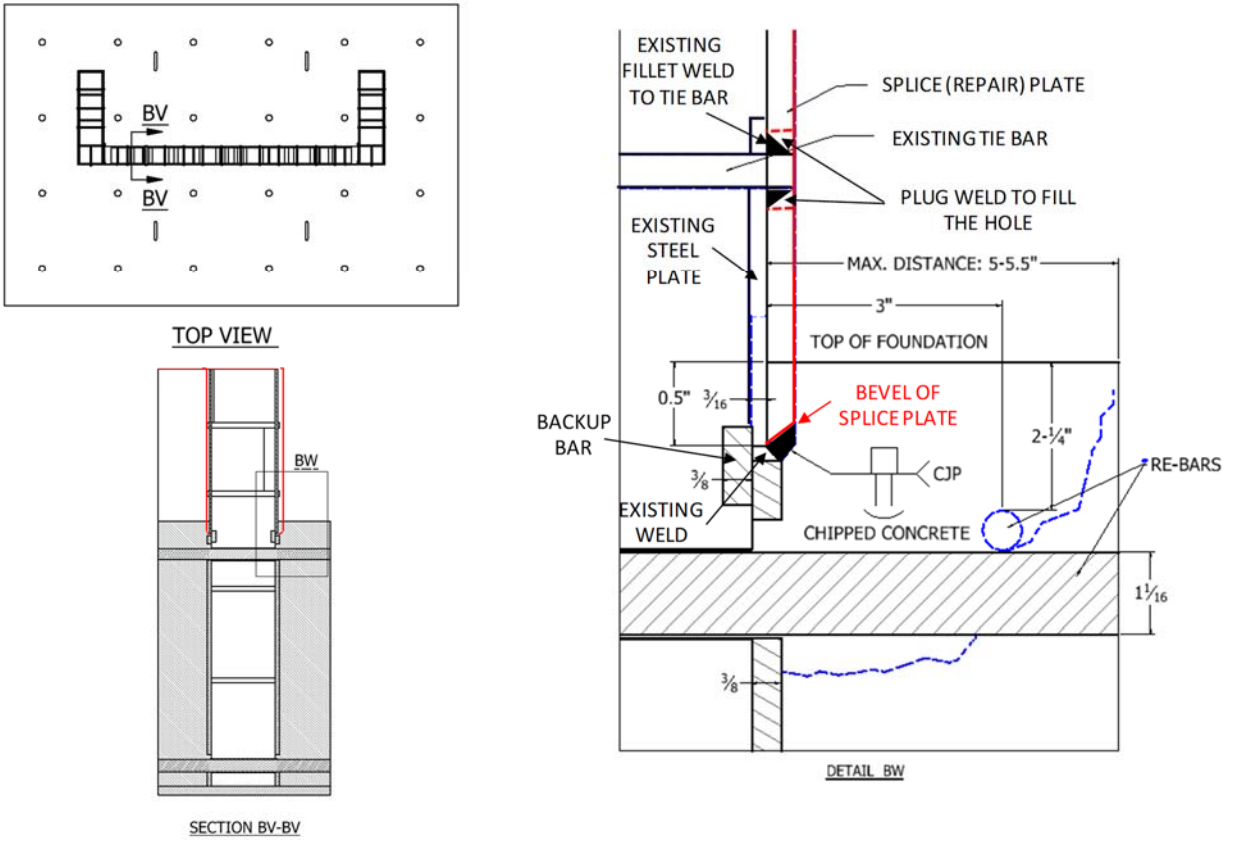
Figure 4-4. Fillet welding detail at the footing.

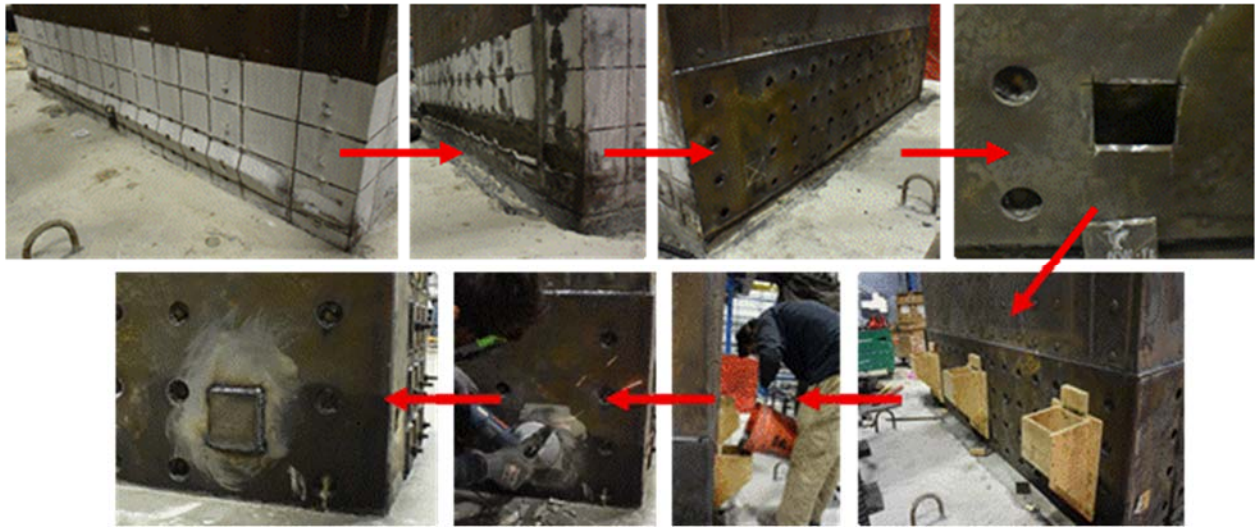
Figure 4-5. Repair sequence of flanges

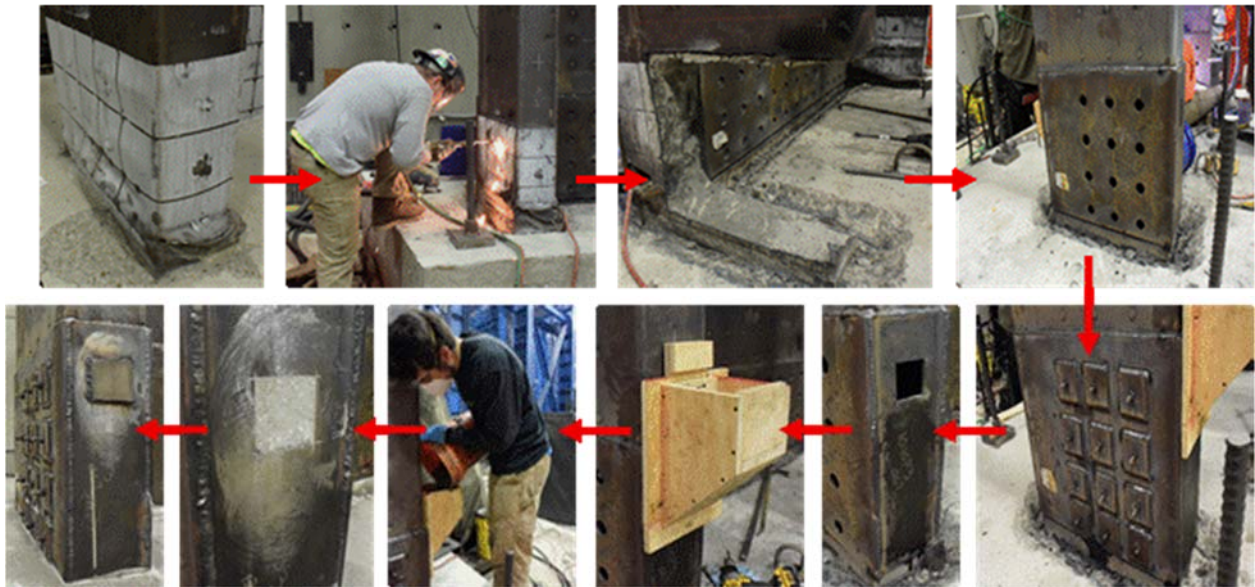
Figure 4-6. Repair sequence of webs

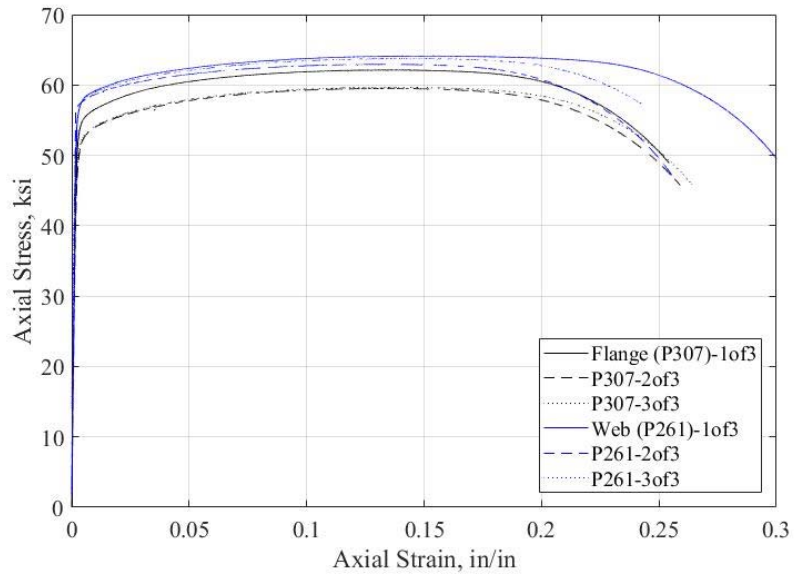
Figure 4-7. Coupon tests of steel plates at flange (p307) and web (p261) for C2

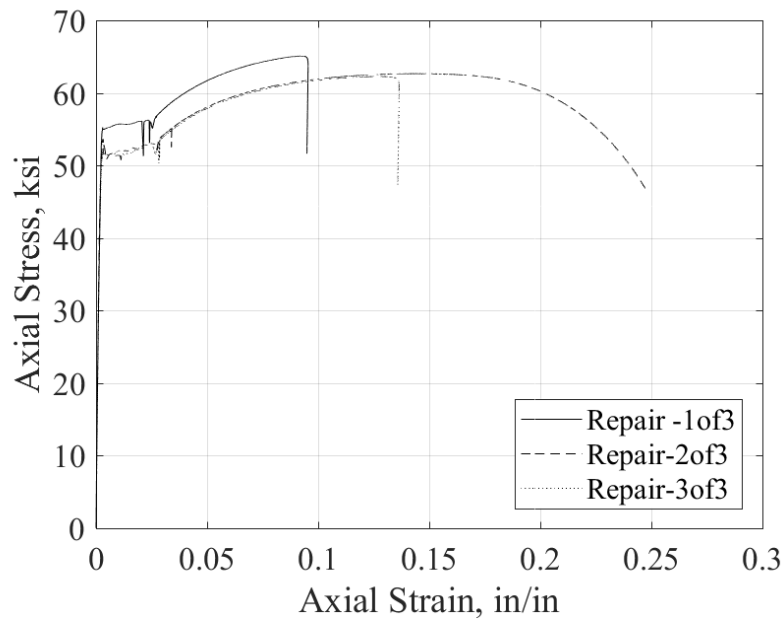
Figure 4-8. Coupon tests of repairing steel plates

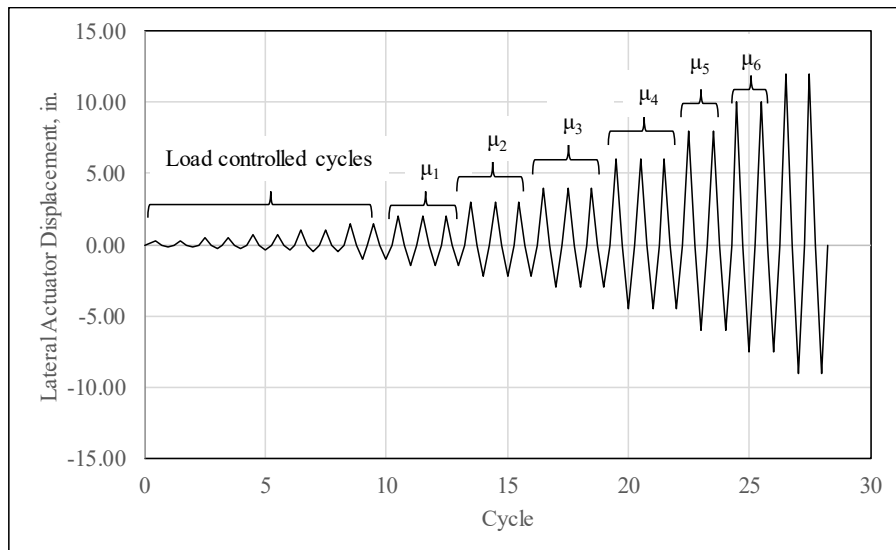
Figure 4-10. Loading protocol for C-Shaped specimens

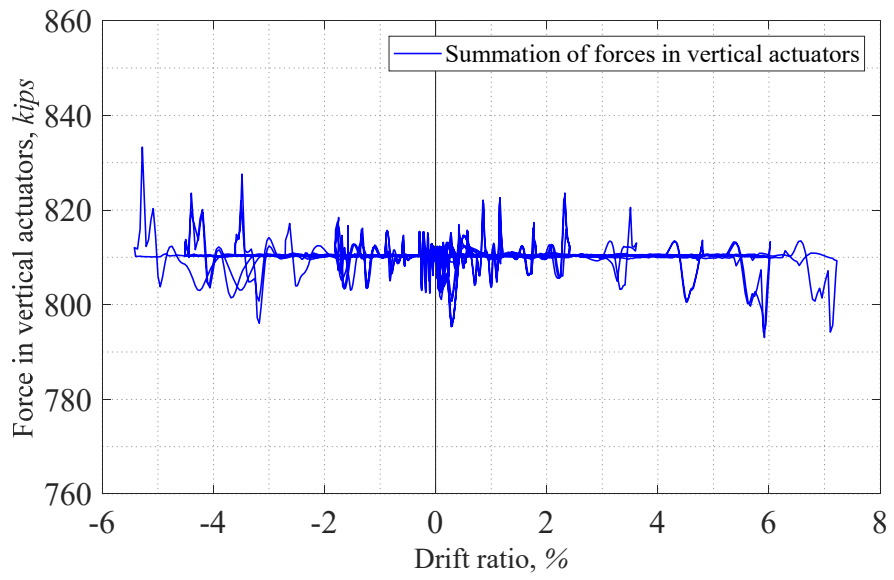
The vertical actuators were driven in a force-controlled mode such as to apply constant axial force to the specimen cross-section. The summation of the axial force in the vertical actuators was tracked during the test to verify that it remained constant throughout testing, as shown in Figure 3-8. The distribution of axial strains across the cross-section were also tracked after engaging the vertical actuators, to verify that the cross-section was subjected to uniform stresses under the applied axial loading, even though loading was only applied to the flange. Results obtained from the strain gauges located in the plastic hinge region of the specimen confirmed that this was the case, as shown in Figure 3-9 for normalized axial strains across a cross-section at 29-7/16 in. from the top of footing on Repaired Specimen C2.

Figure 4-13. Sum of axial forces in the vertical actuators during test of Repaired Specimen C2

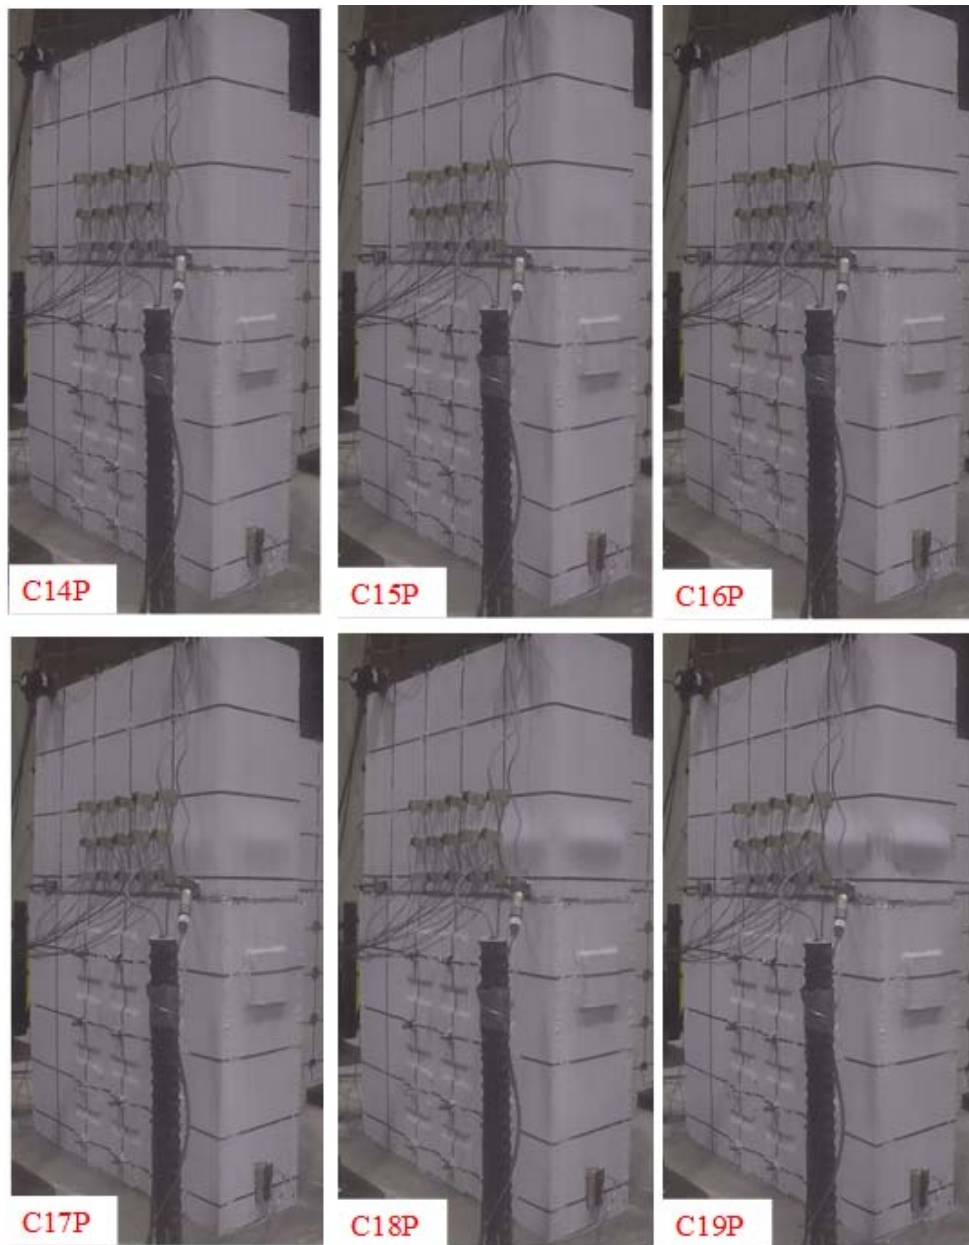
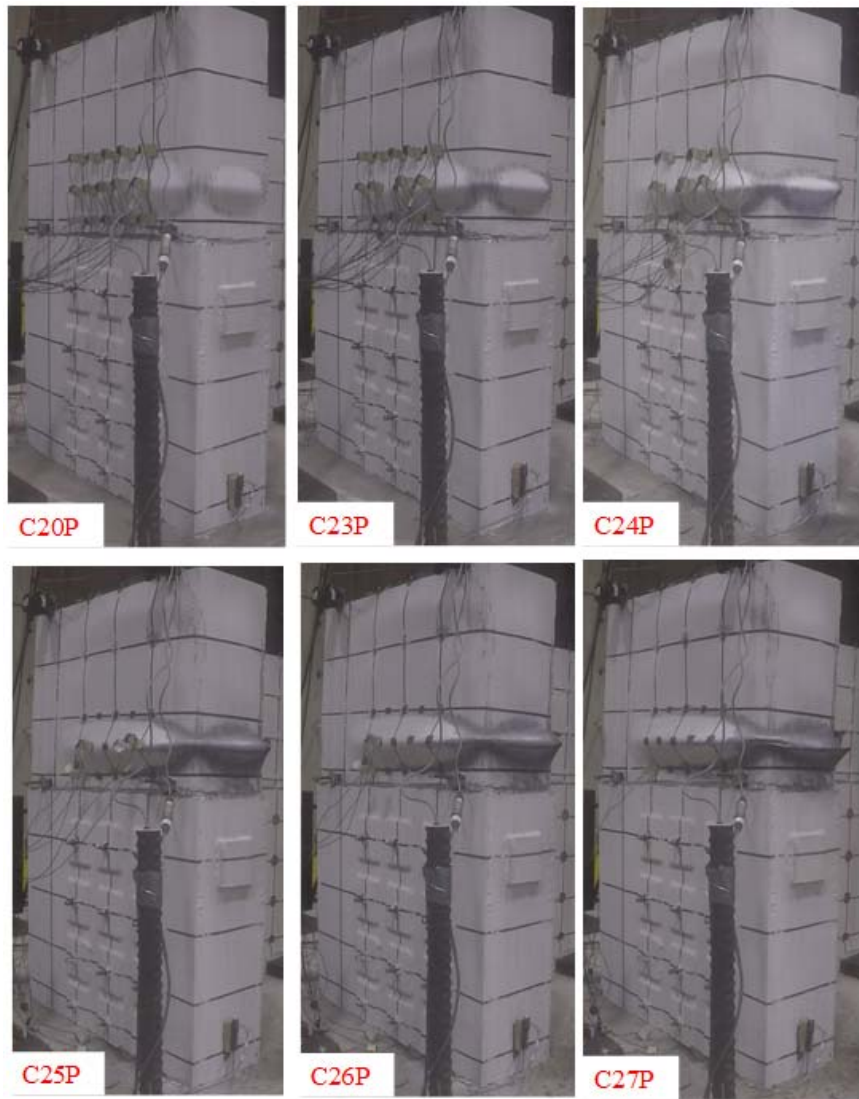
Figure 4-15. North-West views of the North Web of Repaired Specimen C2 at positive peaks

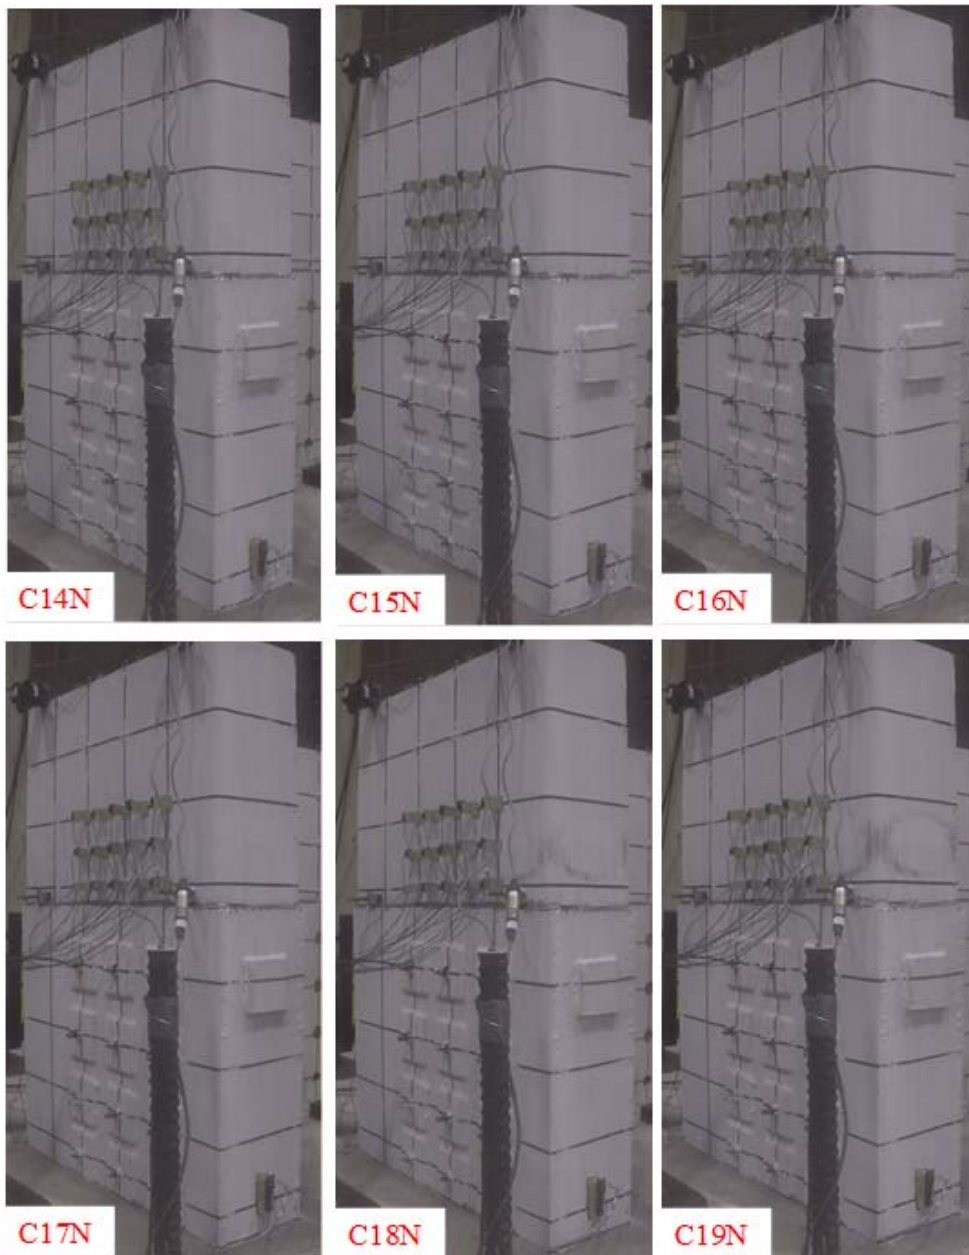
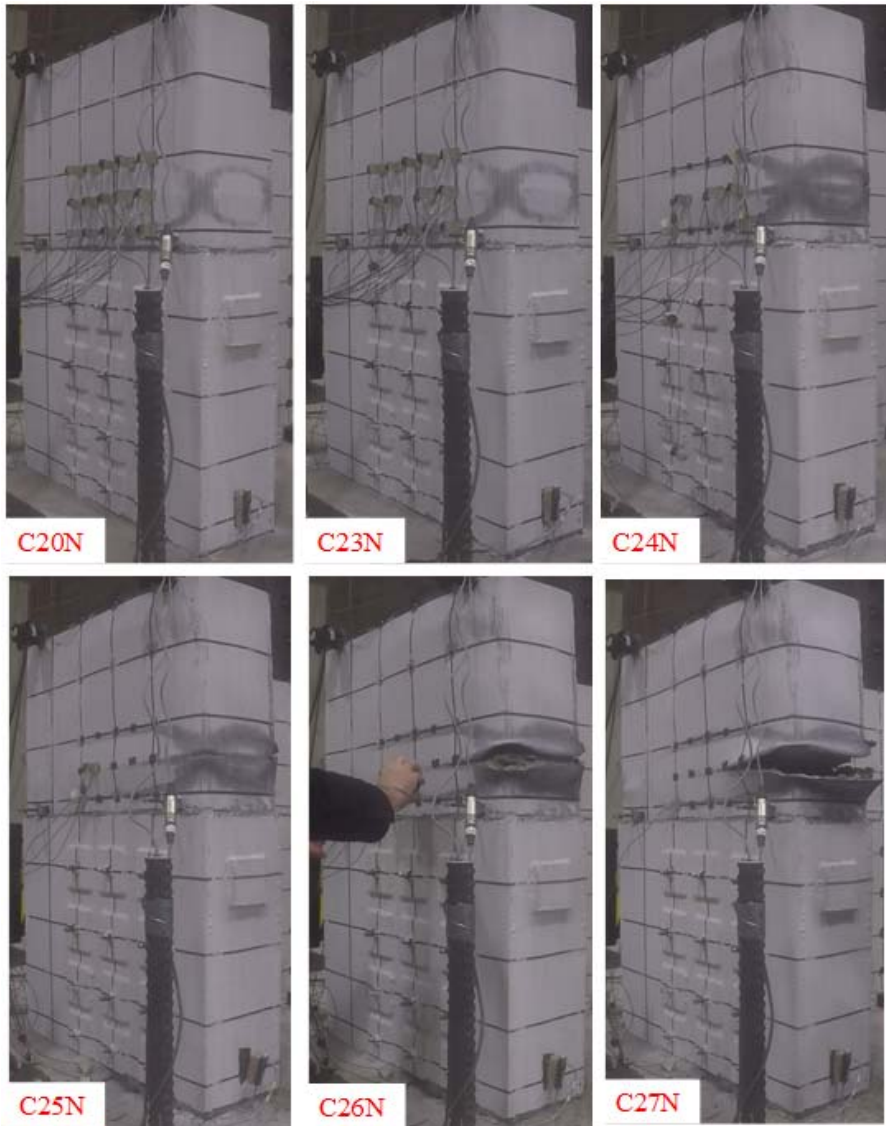
Figure 4-16. North-West views of the North Web of Repaired Specimen C2 at negative peaks

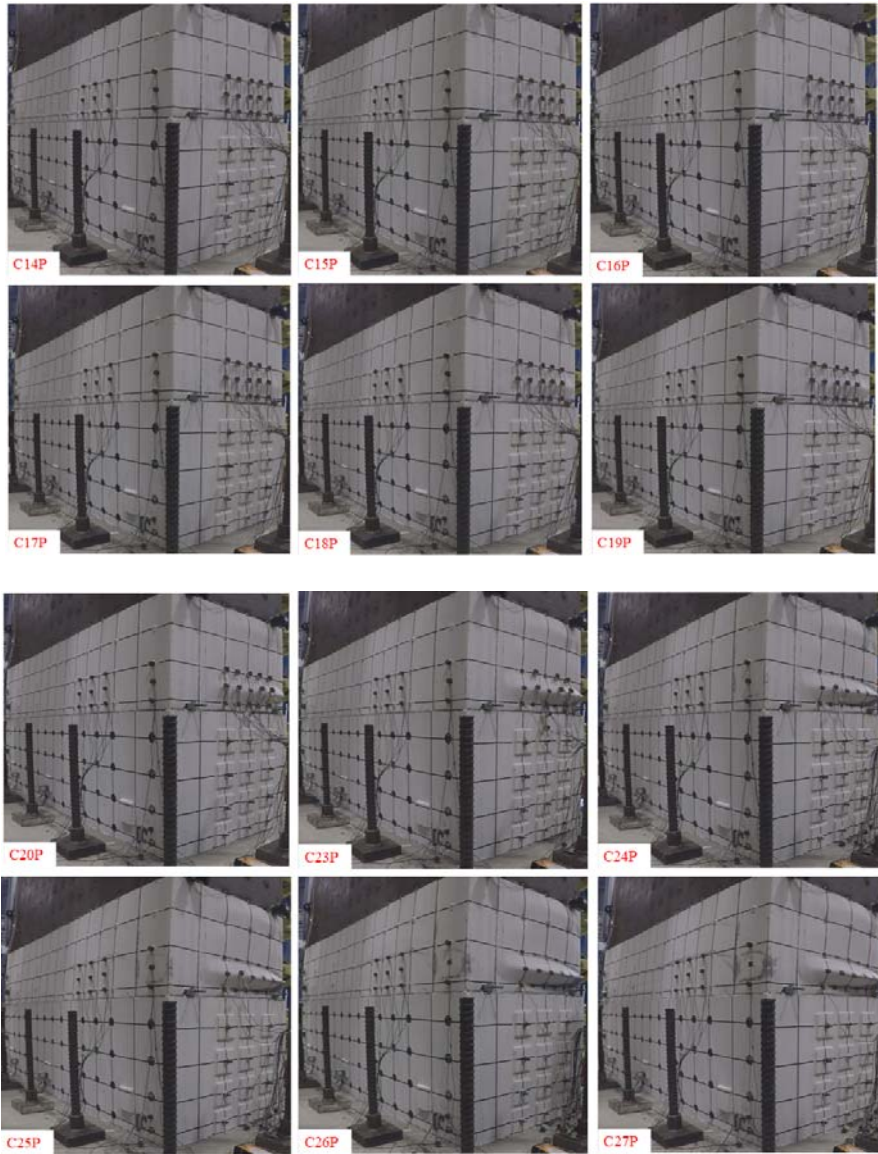
Figure 4-17. East view of the flange and North-East view of the North web of Repaired Specimen C2 at positive peaks

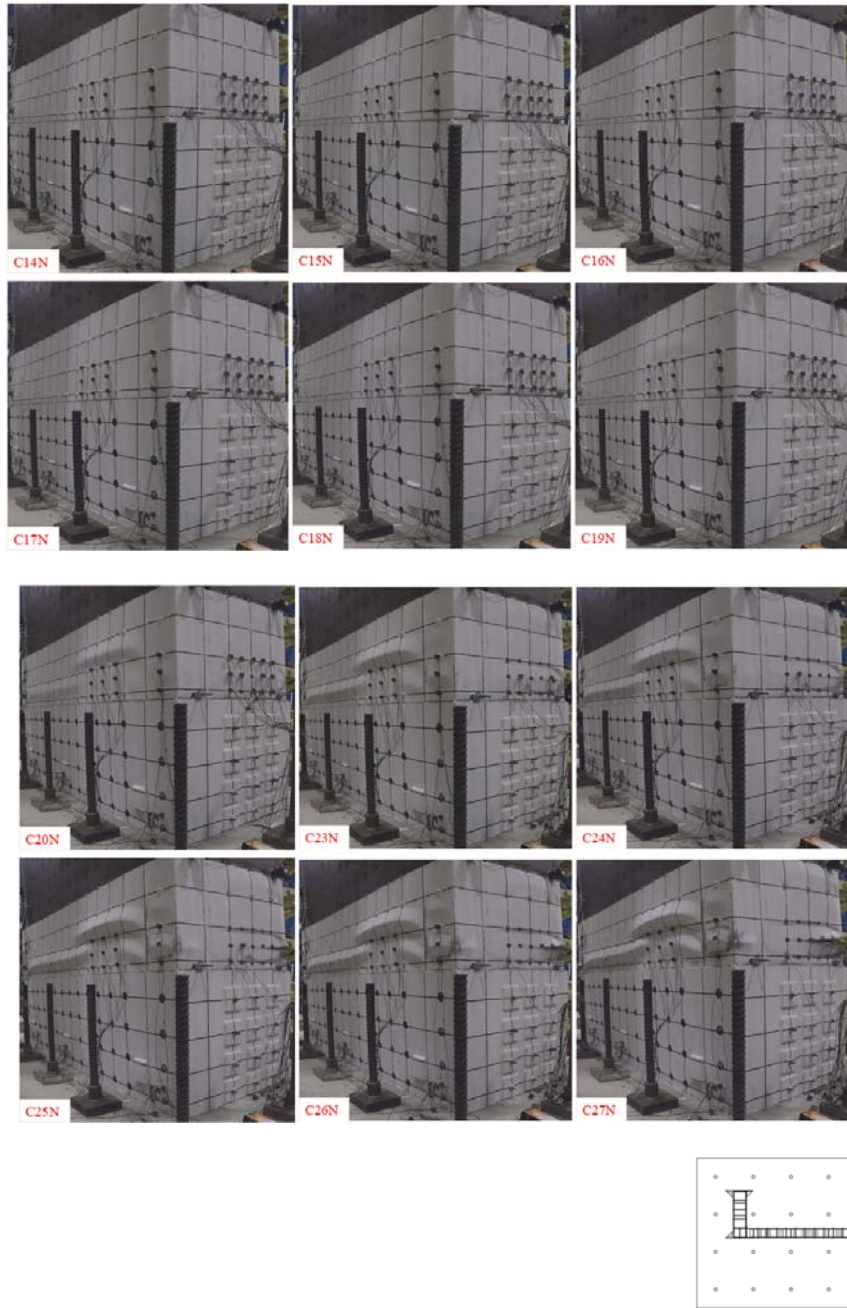
Figure 4-18. East view of the flange and North-East view of the North web of Repaired Specimen C2 at negative peaks

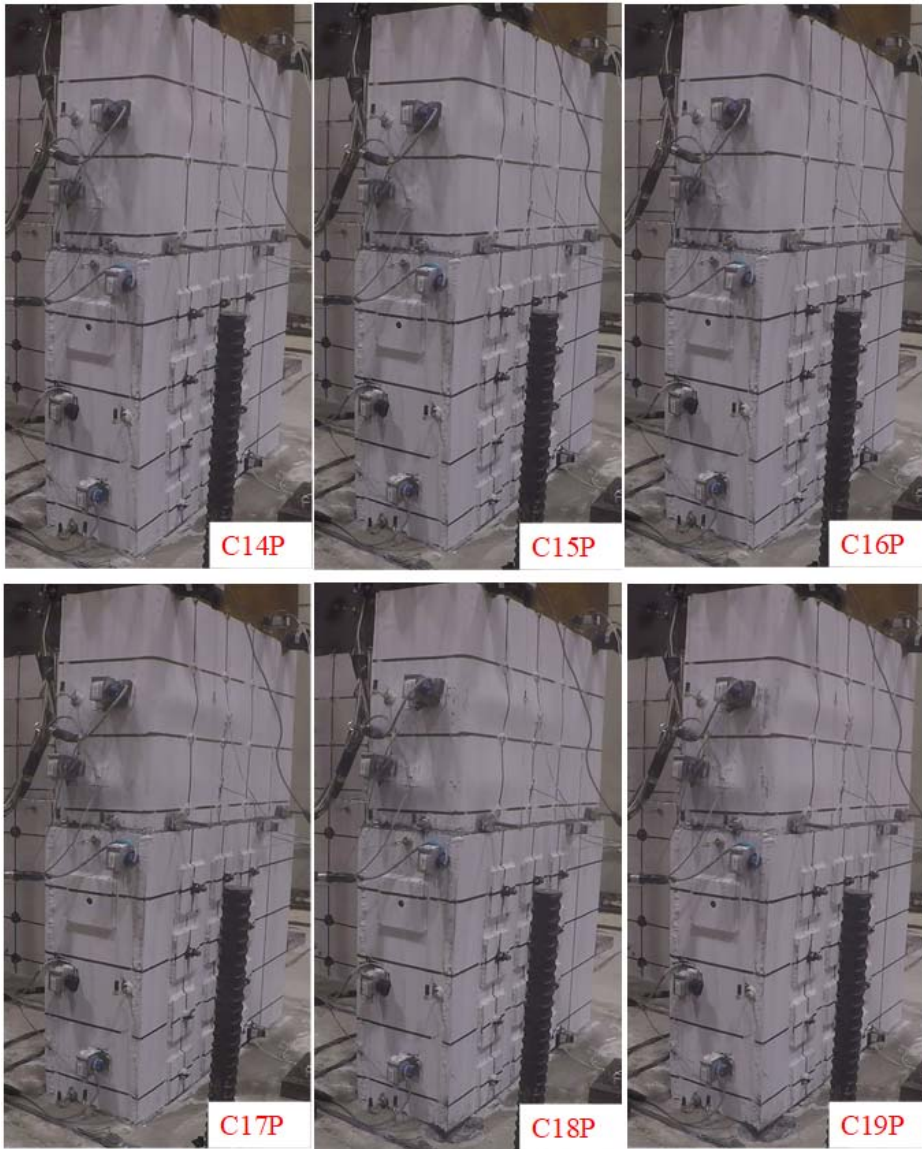
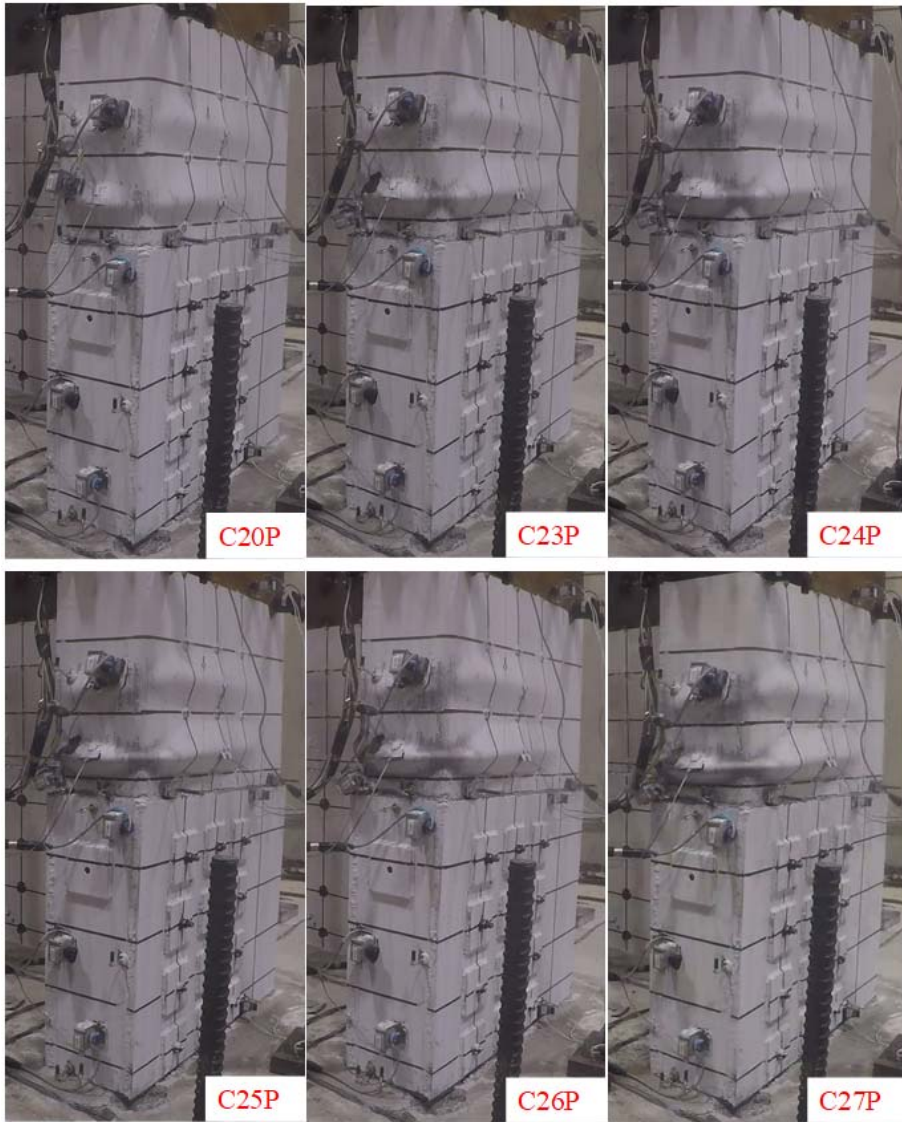
Figure 4-19. South-West views of the South Web of Repaired Specimen C2 at positive peaks

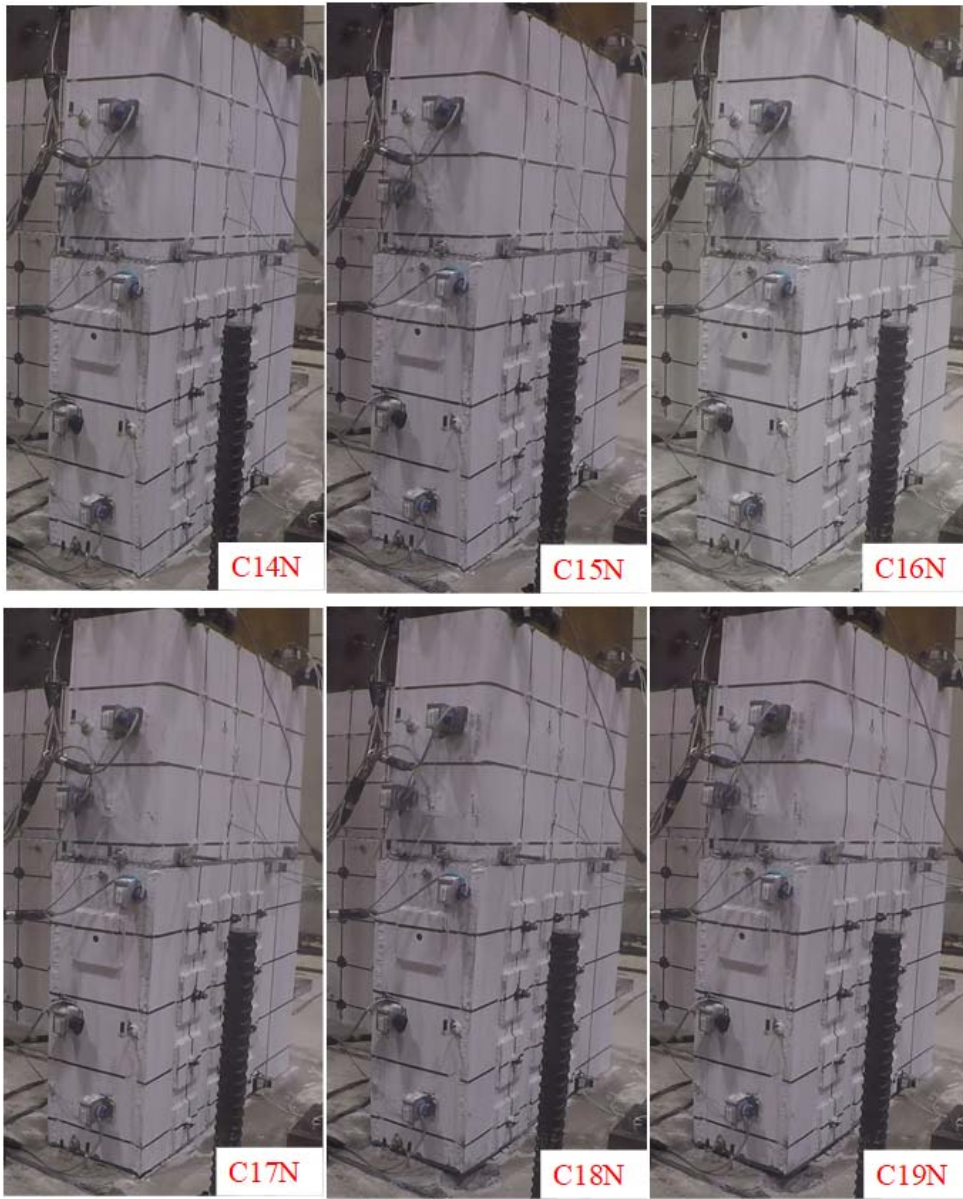
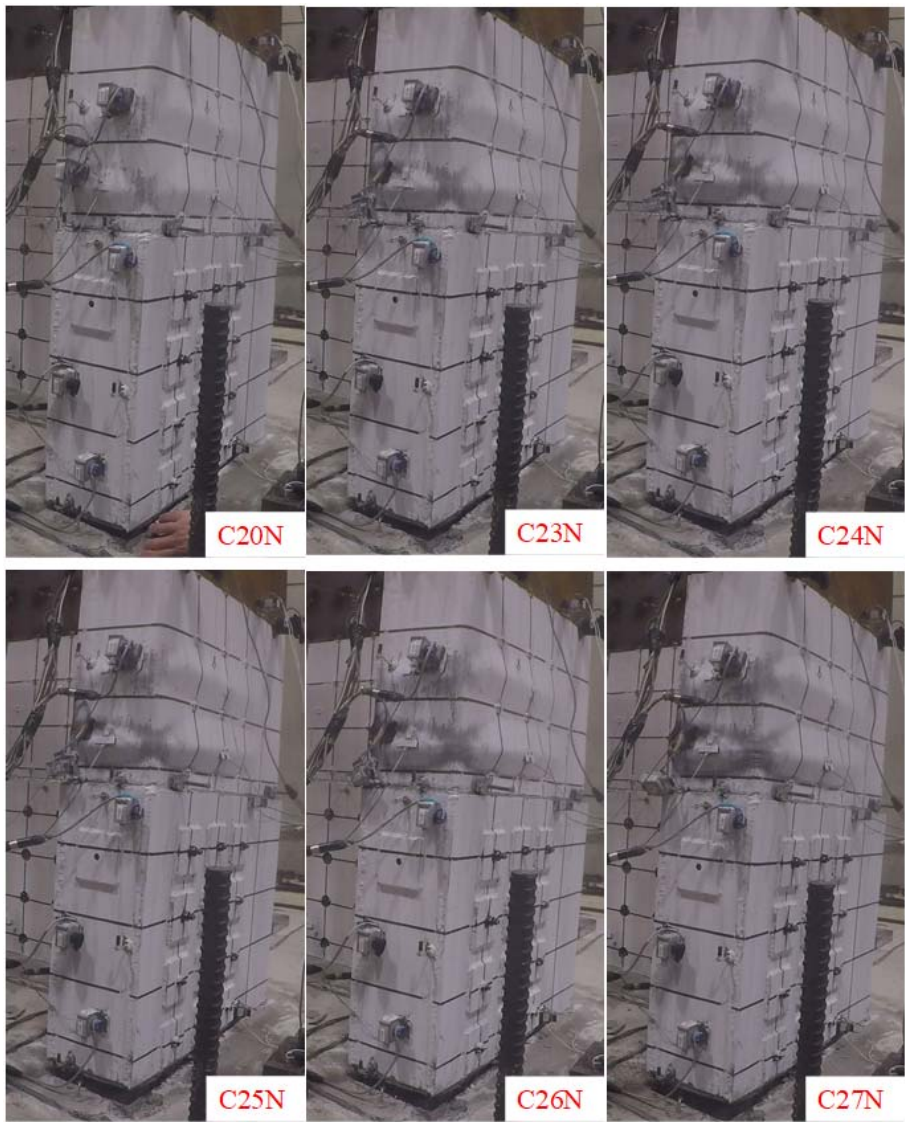
Figure 4-20. South-West views of the South Web of Repaired Specimen C2 at negative peaks
