Cyclic Inelastic Behavior of C-Shaped Composite Plate Shear Walls/Concrete Filled (C-PSW/CF)

(CPF Research Grant # 06-16)

**Cyclic Inelastic Behavior of C-Shaped Composite Plate Shear
Walls/Concrete Filled (C-PSW/CF)**

Final Report

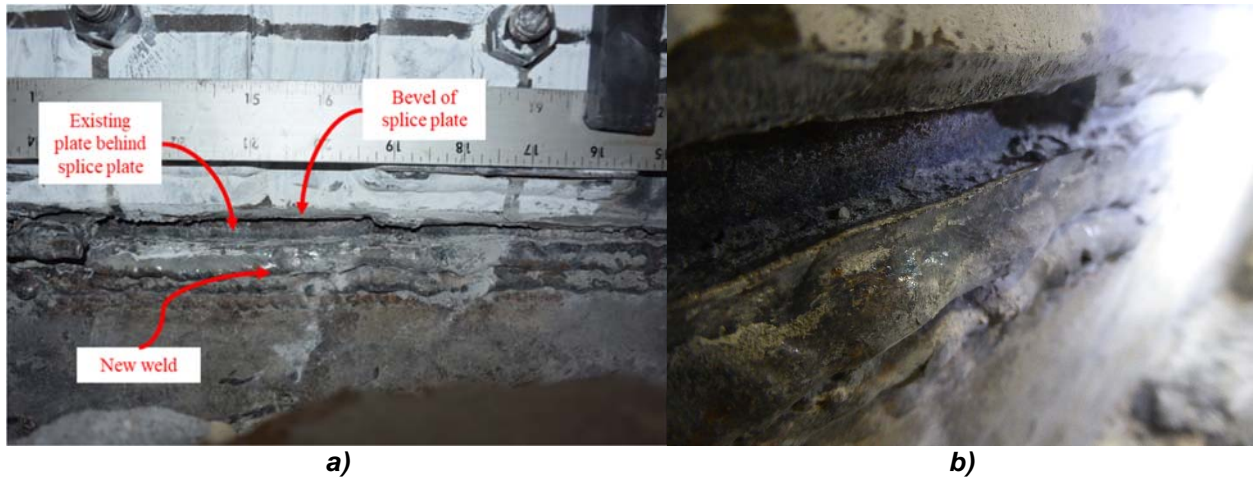
Figure 4-23. Close-up pictures of the fracture propagation at SWS from: a) front view and b) side view

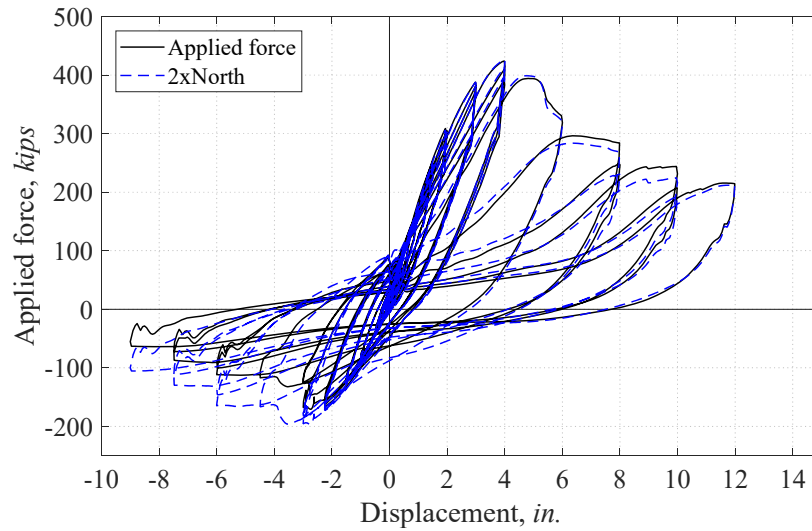
displacement obtained at $0.8M_{base,max}$ after post-peak of the backbone curve of the test setup was taken for the ultimate displacement (δ_u). Then, using Equation 3.2, ductility was calculated as 2.58/-4.22 in the positive and negative directions.

Figure 4-24. Applied lateral force vs. top drift relationship for Repaired Specimen C2

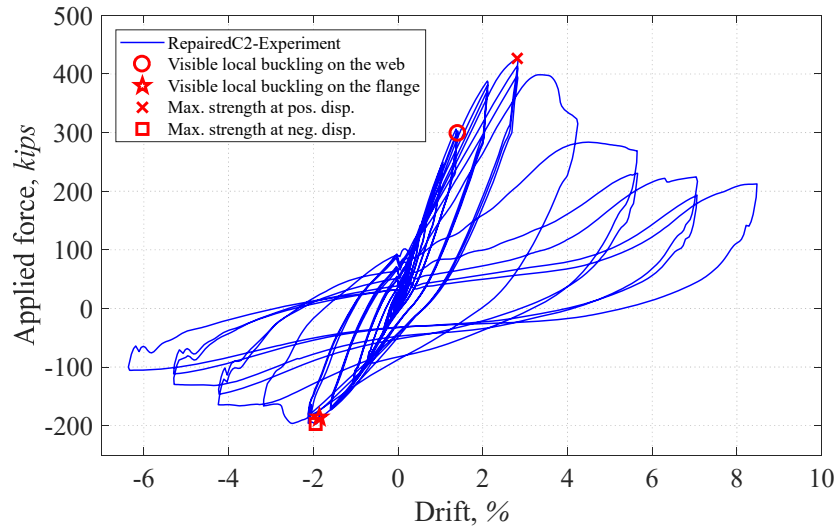
Figure 4-25. Some important points marked in the applied lateral force vs. top drift relationship for Repaired Specimen C2

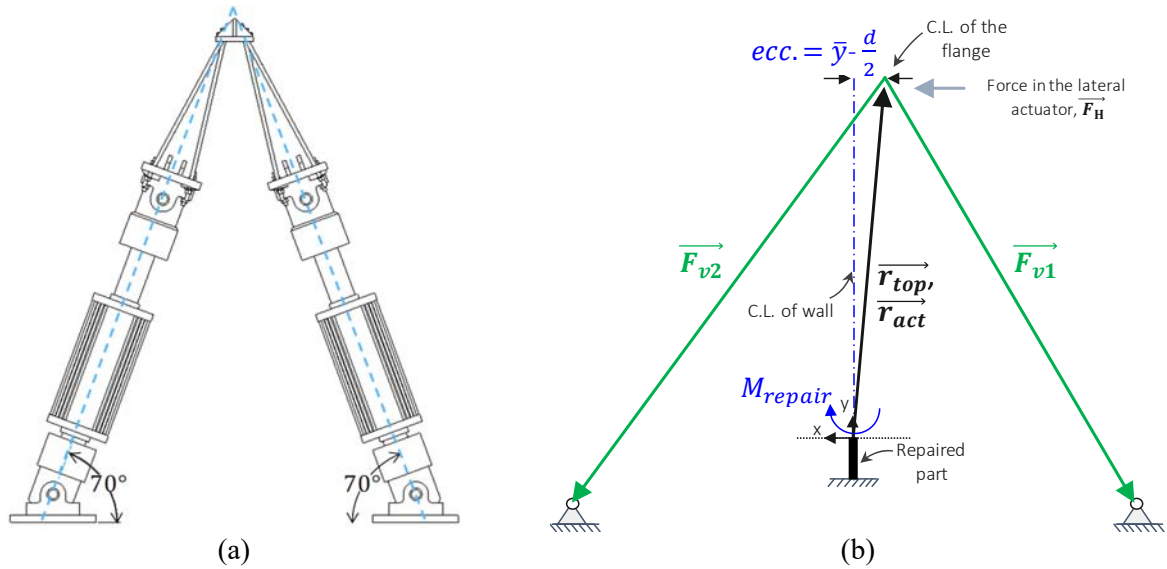
Figure 4-26. (a) Inclination angle of vertical actuators at zero displacement; (b) Free body diagram of the specimen wall at zero displacement

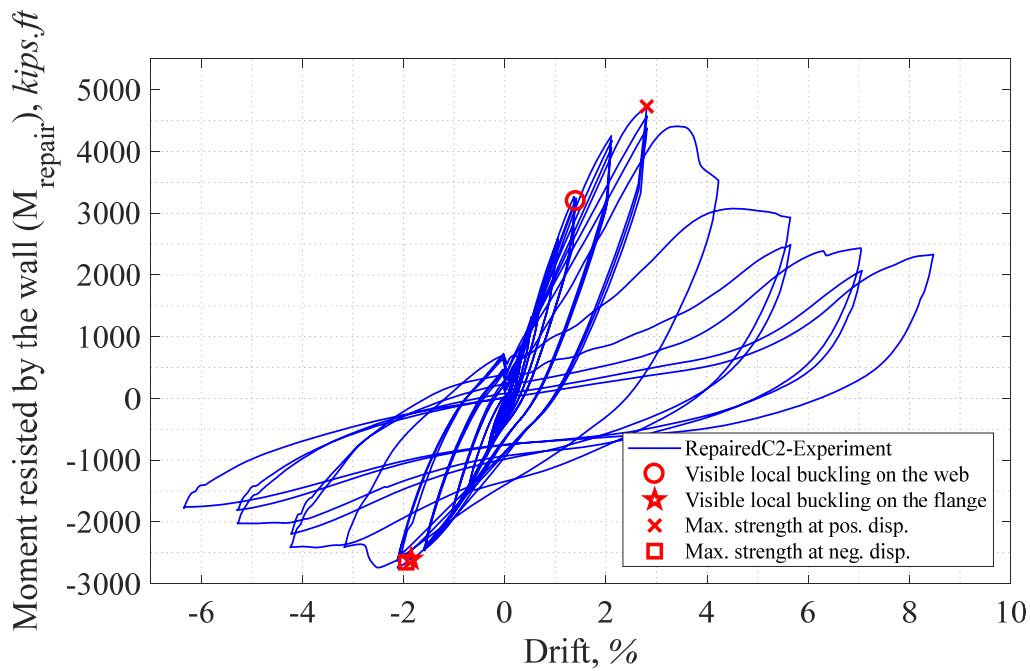
Figure 4-27. Calculated experimental base moment vs. top drift relationship for Repaired Specimen C2

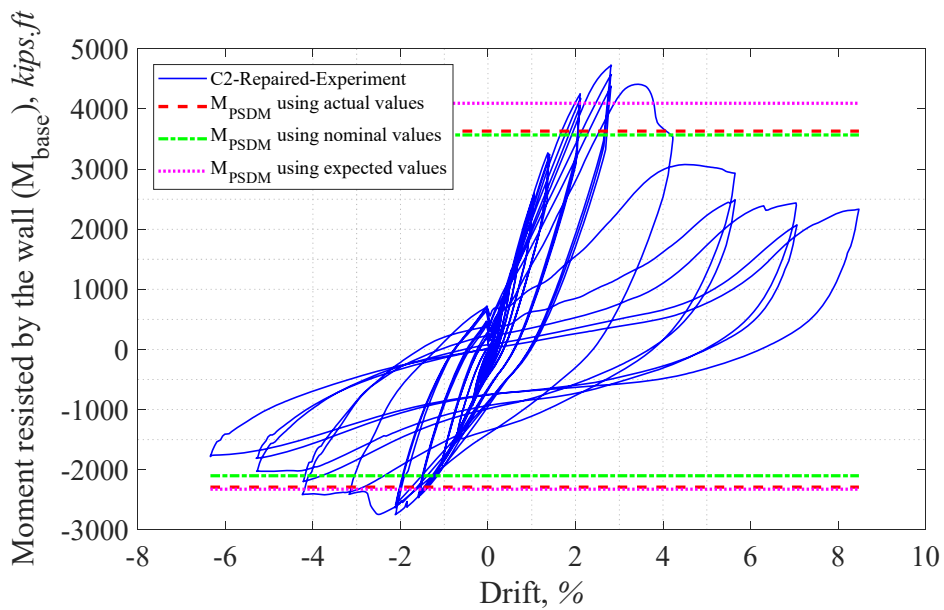
Figure 4-33. Comparison of calculated theoretical resistance moments and the experimental moment at cross-section above repair for Repaired Specimen C2

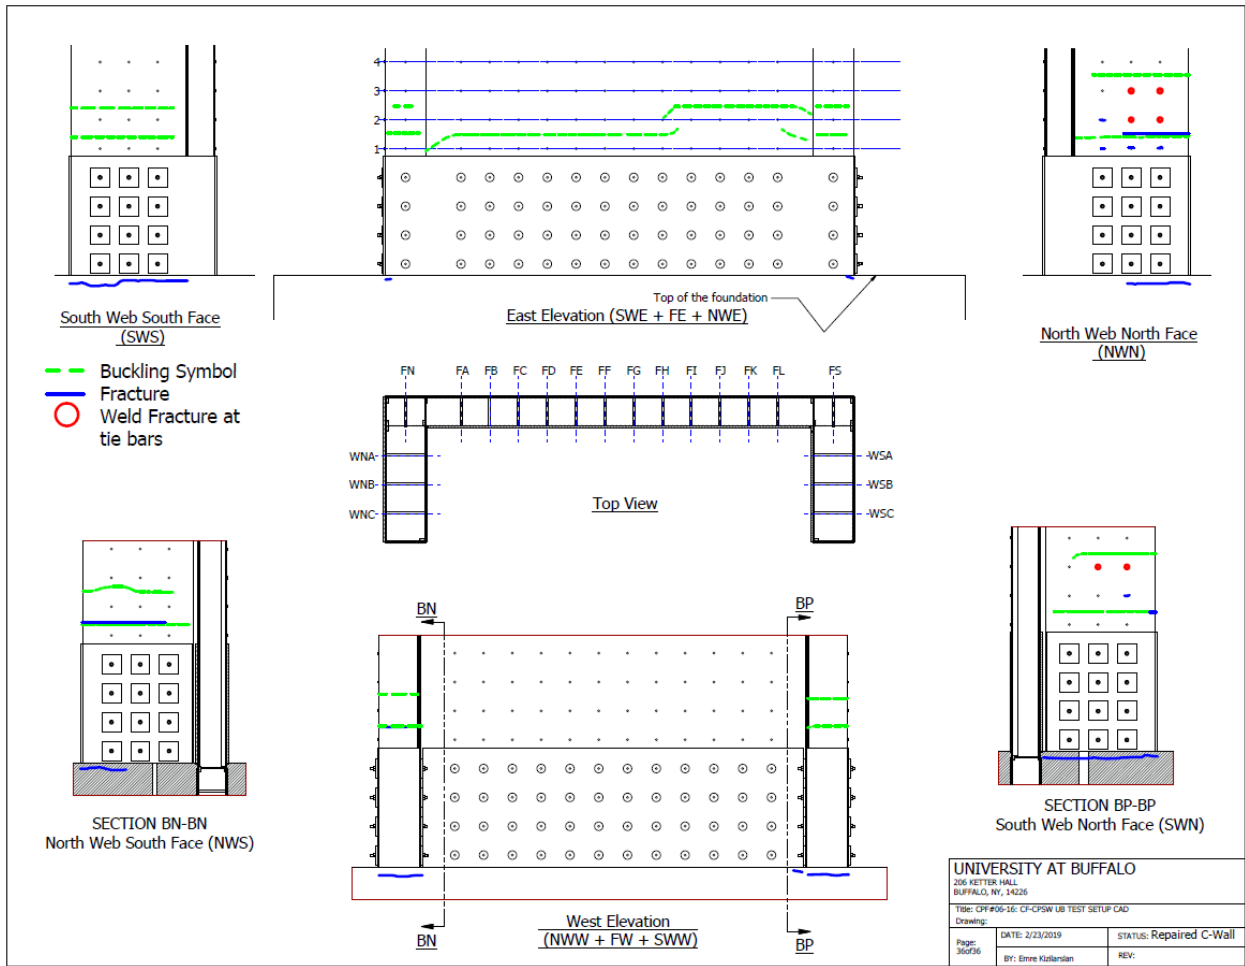
Figure 4-34. Sketch of post-test damage inspection of the wall steel plates for Repaired Specimen C2

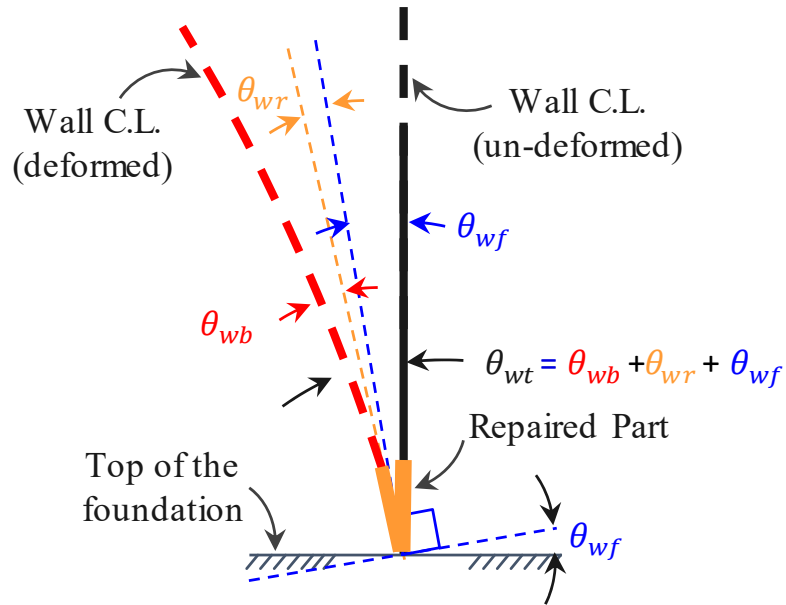
Figure 4-37. Composition of wall rotations above repaired part of the wall

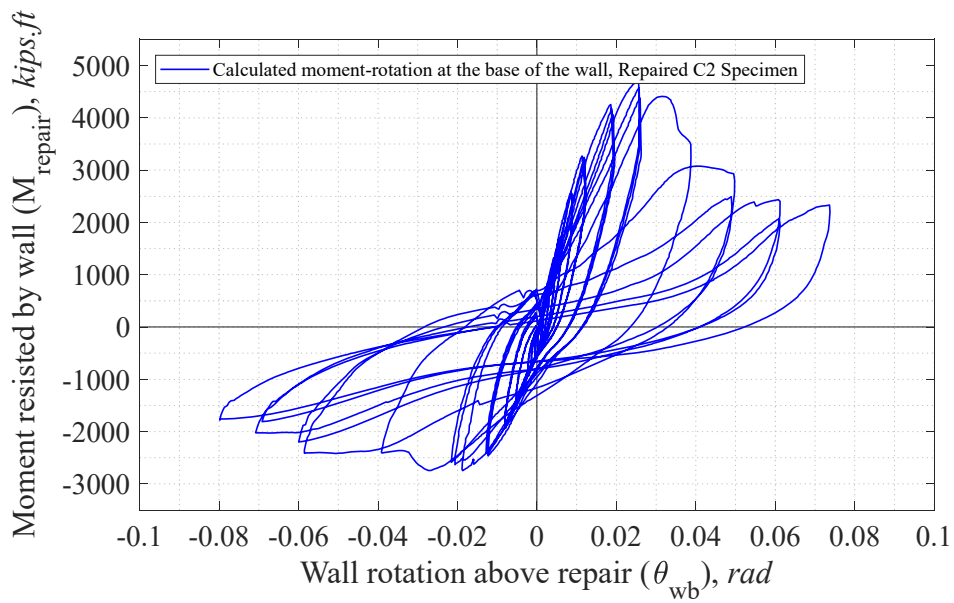
Figure 4-38. Calculated experimental base moment vs. wall rotation above repaired part for Repaired Specimen C2

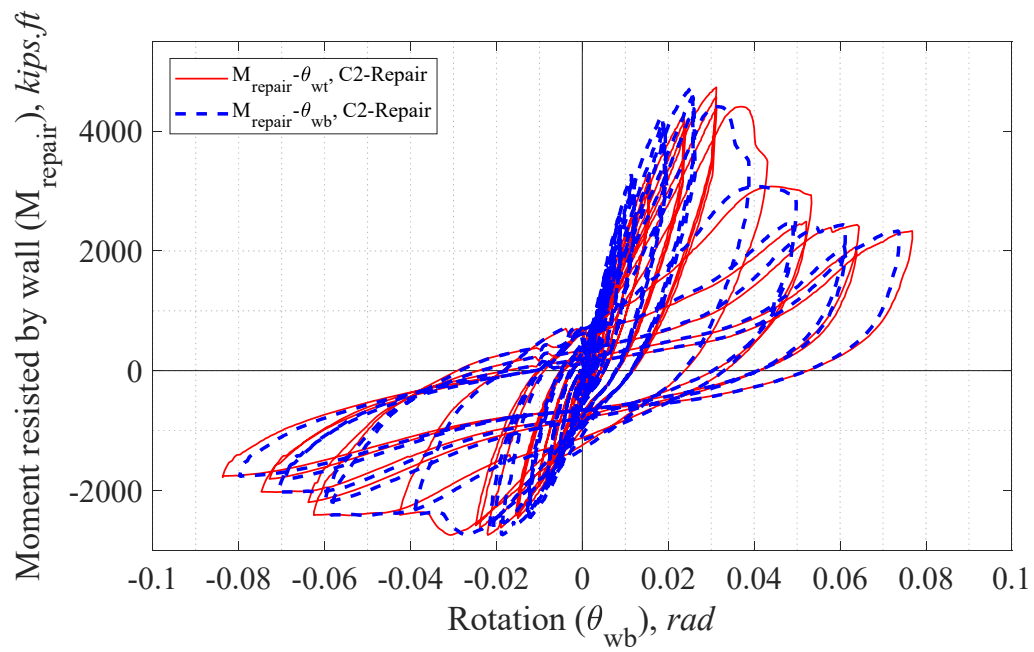
Figure 4-39. Comparison of calculated experimental base moment vs. wall base rotation and vs. total base rotation for Repaired Specimen C2

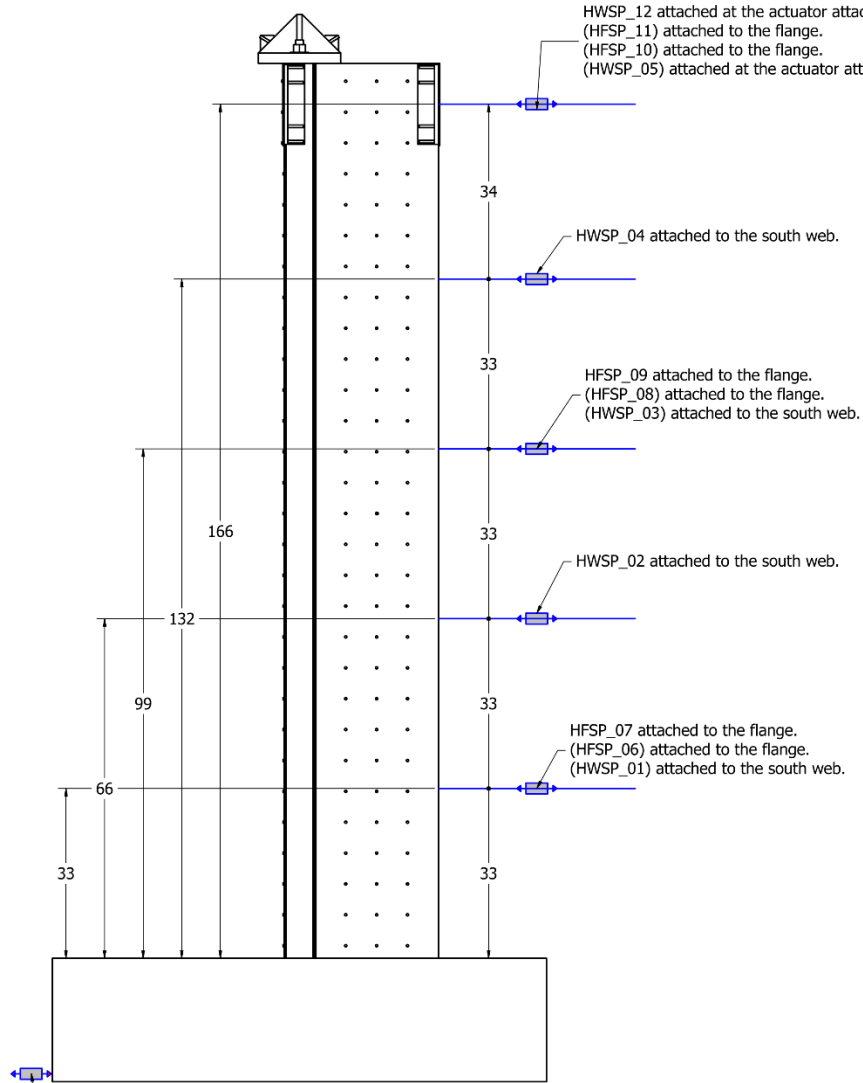
Horizontal String Pots
 North Elevation

HSP_13 See plan view.
 (HSP_14) See plan view.
 Check for foundation slippage.

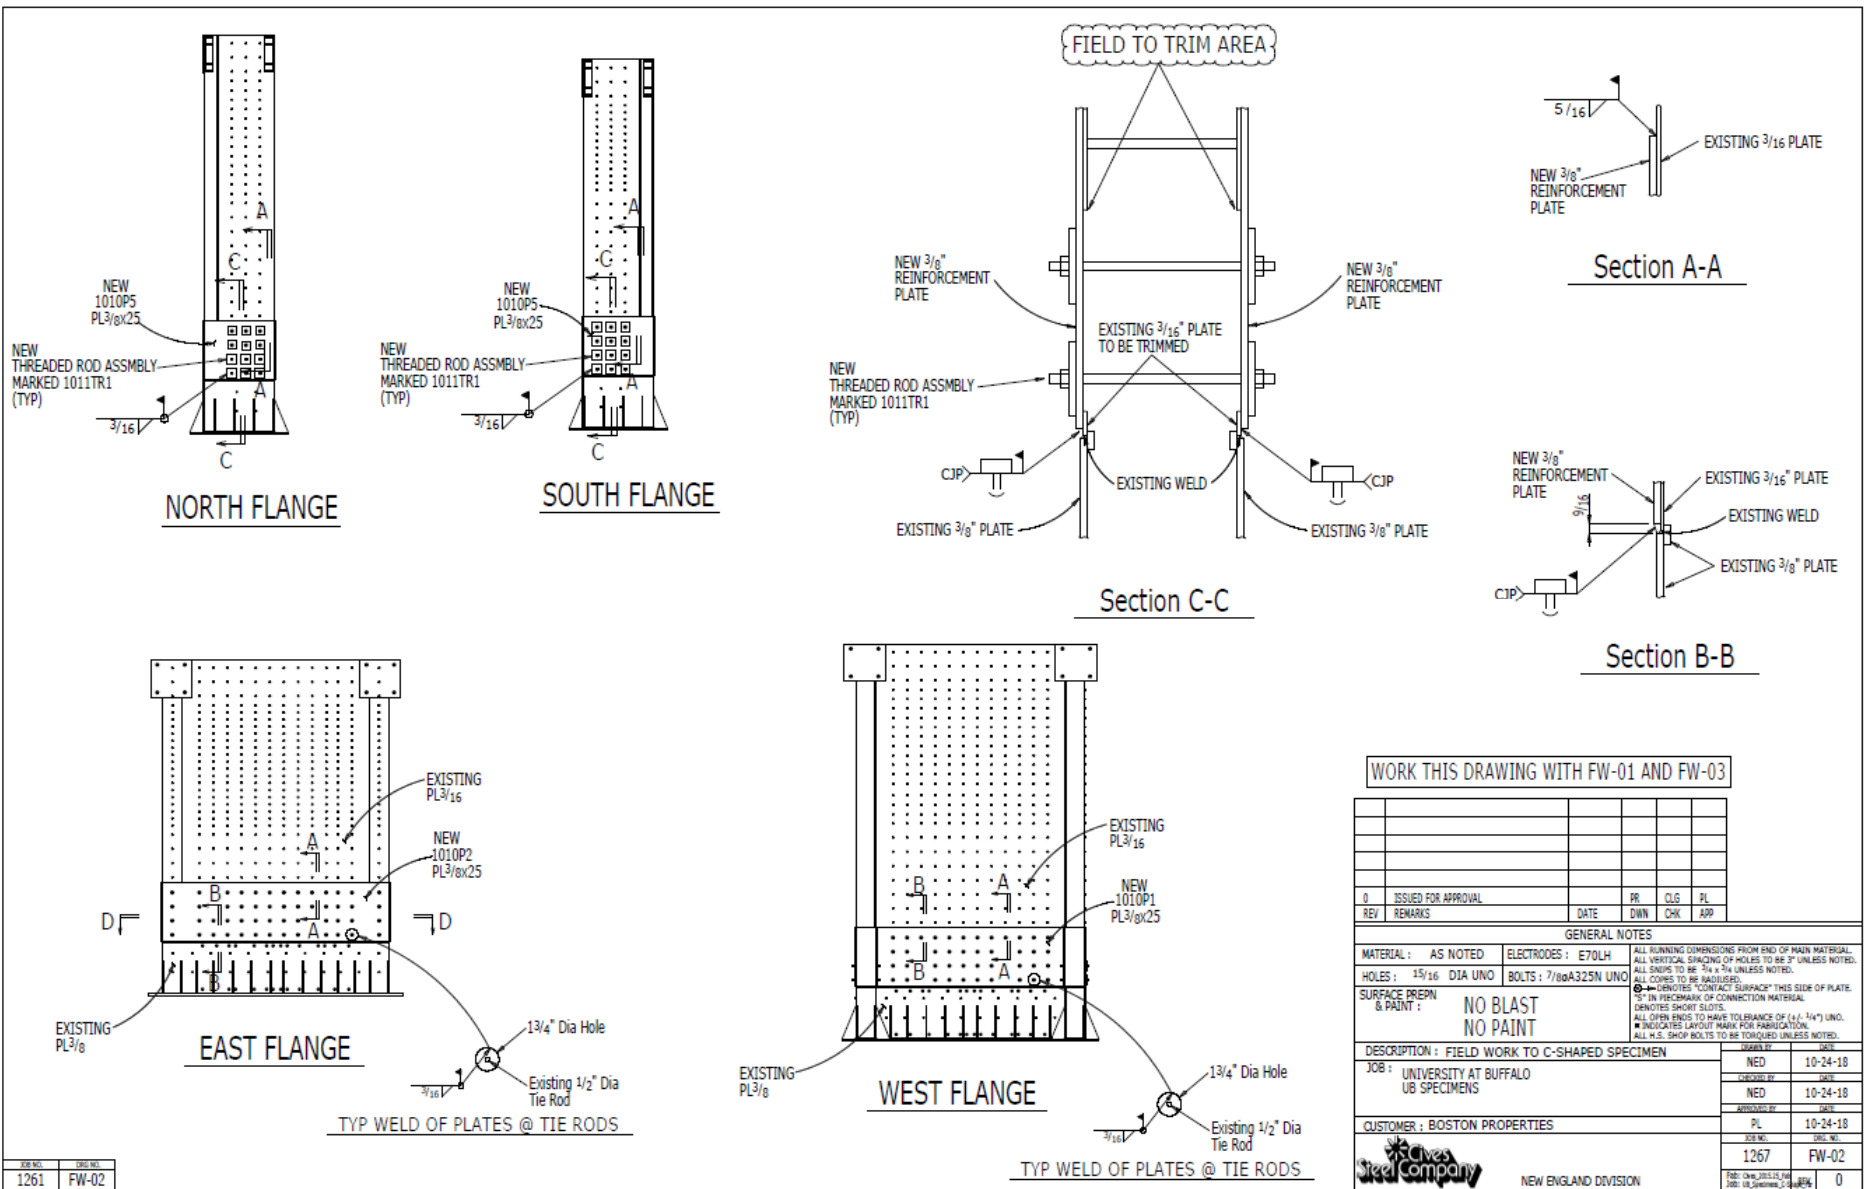
Furthermore, even though it is not shown in the drawings, the bottom of the splice plates were beveled to facilitate their welding to the thicker wall plate in the footing.
